# CITY OF STAMFORD

## Glenbrook Community Center

#### FACILITY CONDITIONS ASSESSMENT

March 6, 2020

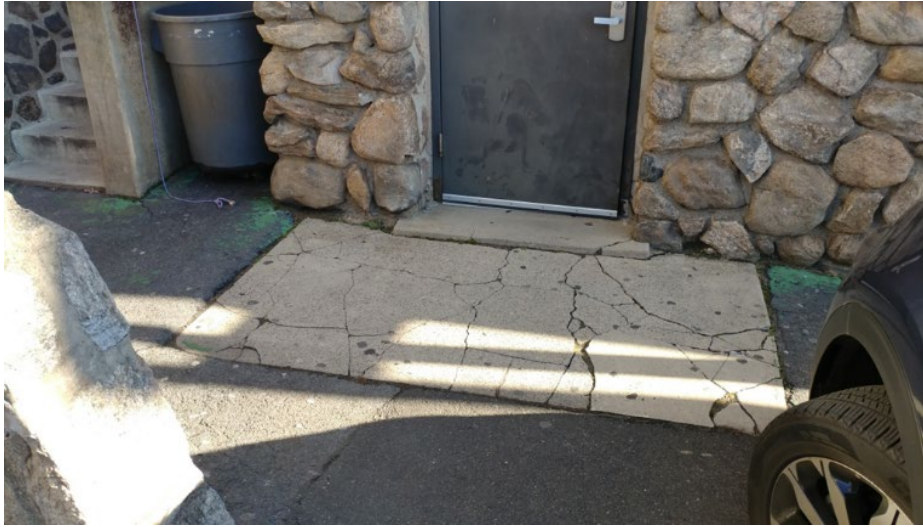
**DOOR APPROACH IN POOR CONDITION**

**CRACKED AND  
WORN PAVING**

Overall the bituminous paving and concrete sidewalks around the site are in good condition. The paving around the pre-school play area was not re-done at the time of the last paving and is showing signs of deterioration and wear. In this area the pavement is cracked and starting to fail. Another concern is settling of pavement at entrances or transitions between dissimilar materials, such as concrete slabs and bituminous paving. Pavement at doors is required to be flush for accessibility, a ½" lip is allowed. As pavement ages it often settles causing gaps which must be addressed.

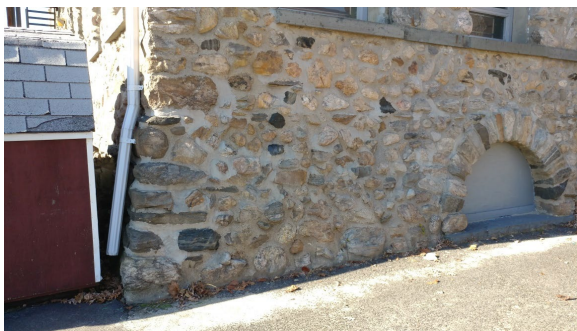
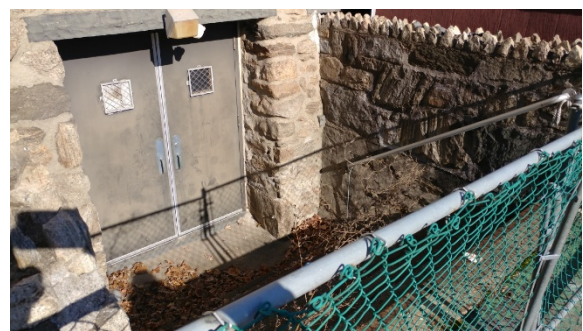
Roof drainage flows from the downspouts directly onto the paving surfaces which wears the paving and causes erosion during storms. More importantly the water can pond and cause slippery and icy spots for pedestrians and vehicles. Improvement to the existing drainage is a relatively low priority, but one that should be considered in the future.

**SITE STORM DRAINAGE SURFACE RUN OFF and EXTERIOR STAIR WELL DEBRIS**

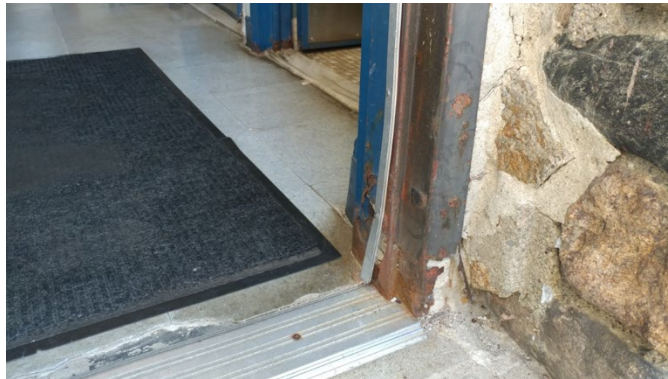
### DOOR FRAME DETERIORATION

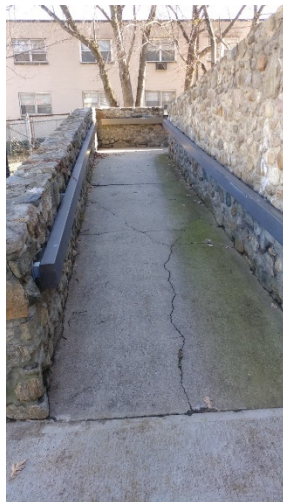
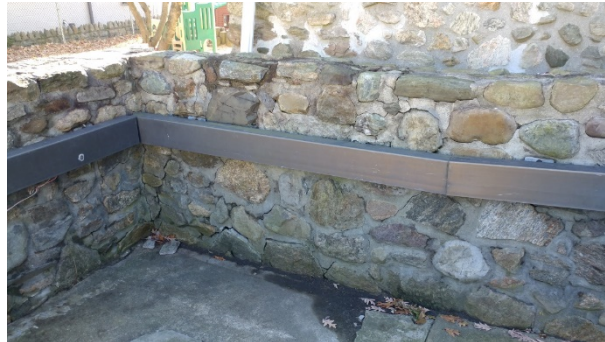
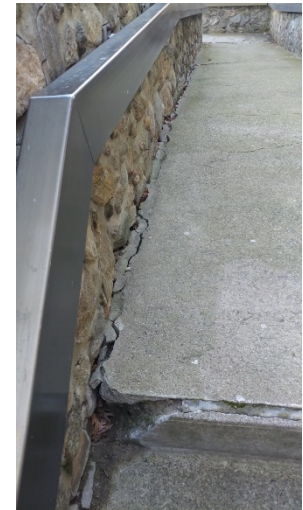
The front entrance ramp and stairs are in need of significant repairs. The existing concrete ramp surface is cracked and in disrepair. The existing concrete needs to be removed and replaced altogether. There

are gaps between the ramp / stair walls and the concrete paving allowing water infiltration into the base of the stone masonry. Some portions of the stone walls at the ramp have begun to very slightly lean due to the freeze/thaw. The immediate need however is repairing cracked sections of masonry ramp wall. This will require rebuilding some areas and repointing others, generally from the top down where the deterioration is the worst. The longer the ramp remains before renovating, the more significant the damage will be to the stone walls. In the long run, portions of the ramp walls may need to be reconstructed from the base up to correct the water damage. If reconstructed from scratch the ramp would need to be designed to meet the

### EXTERIOR RAMP and STAIR IN POOR CONDITION. SIGNIFICANT MORTAR CRACKS AND WALL MOVEMENT. CRACKED CONCRETE PAVEMENT AND LOOSE HANDRAILS

The ramp and stair handrails are loose, the integral lighting is no longer functional, and the profile does not meet accessibility requirements. It is recommended that the handrails be replaced entirely with a new code compliant round pipe style, either fastened into the stone sidewalls or installed on posts drilled into the walking surface.

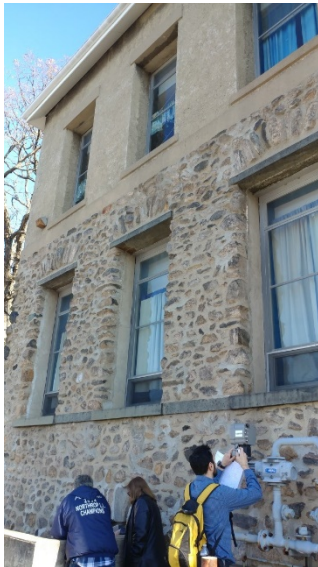
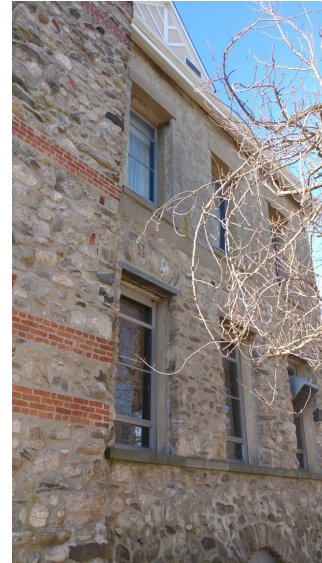
**EXISTING ALUMINUM  
WINDOWS AND WATER  
INFILTRATION AT  
WINDOW HEADS**

The windows are an older style aluminum frame and sash with very poor thermal performance. Despite their age most of the windows are functional and continue to serve the building functions. Contemporary windows offer many improvements over the existing windows and a full replacement should be considered in the future. New windows would offer significantly better thermal performance, energy efficiency and improved appearance / glass. Portions of the building, like the gym, would benefit from laminated safety glazing allowing removal of the heavy metal screens.

Related to the windows, water infiltration was observed at the head of the second floor west facing windows. There does not appear to be any drip edge at those window heads which allows wind driven rain to follow the head back to the window and saturate the underside of the head as well as adjacent interior drywall. A window replacement would be the best time to address water infiltration issues at these heads. Similarly, metal window lintels should be scraped, sanded, primed and painted during window work.

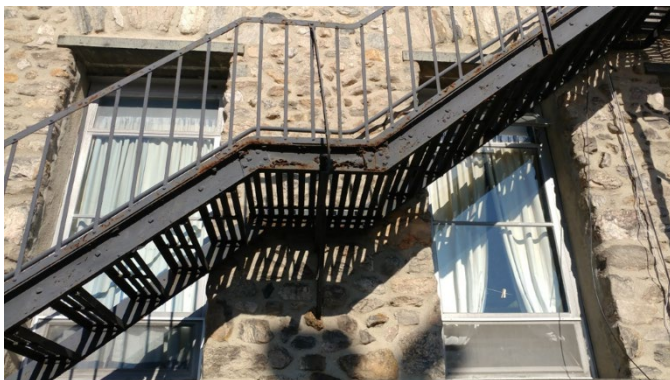
**EXPOSED STEEL PREP and PAINT**

The metal fire escape at the rear of the building is rusting and needs to be scraped, sanded, primed and repainted. The iron structure appears to be sound and should require little or no repair work or replacement of members.

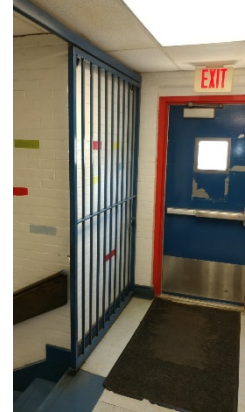
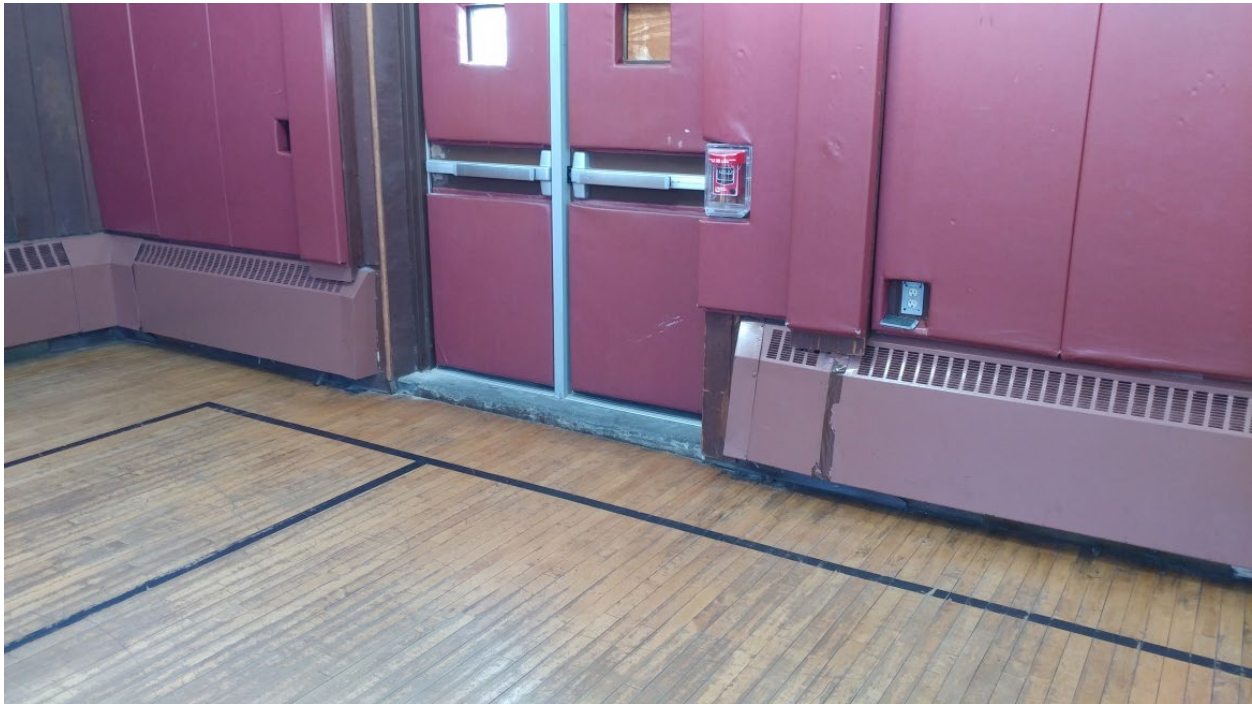
### EXISTING STEP/THRESHOLD AT DOOR

Accessibility violations are very common in older buildings built well before modern codes and standards. Corridor door clearances are not code compliant at all levels. Often doors in stud and drywall construction can be redesigned to meet the modern push / pull required clearances. Where it is not possible or feasible to reconfigure doors, power operators can be installed to meet accessibility standards. The downside to operators is maintenance and future repairs.

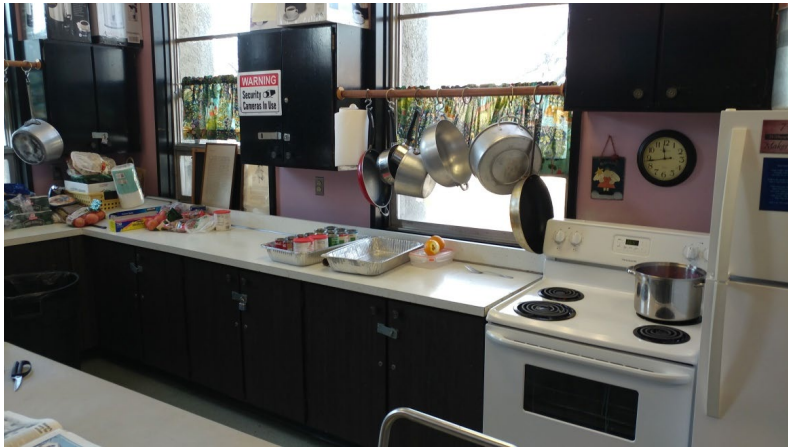
Cabinetry, counters and built in furniture does not meet accessibility requirements. This is particularly applicable in the kitchen on the second floor. The kitchen and other spaces with built in cabinetry are tenant fit out issues which change depending on the use of the spaces, such as the kitchenette on the third floor and convenience sinks within the first-floor rooms. As built in furniture and fixtures are

### **KITCHEN IS NOT ADA COMPLIANT**

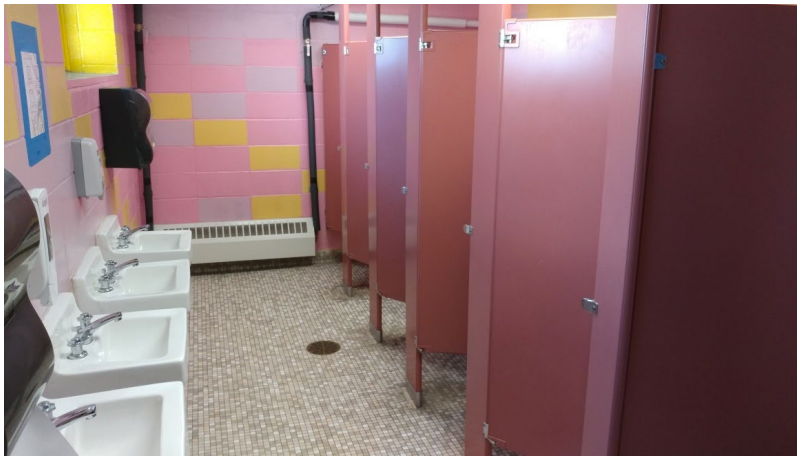
The toilet rooms are in need of upgrades both for accessibility and also due to old and worn finishes. The handicap toilet room on the second floor is missing grab bars which have been added by recent code updates. The two other toilet rooms on the second floor are in poor condition and need new finishes, toilet partitions and plumbing fixtures. The rear group toilet rooms are not accessible and will require a redesign to accommodate handicap compliant toilet stalls and wider entrance doors.

### **GROUP TOILETS IN ANNEX ARE NOT ADA COMPLIANT**

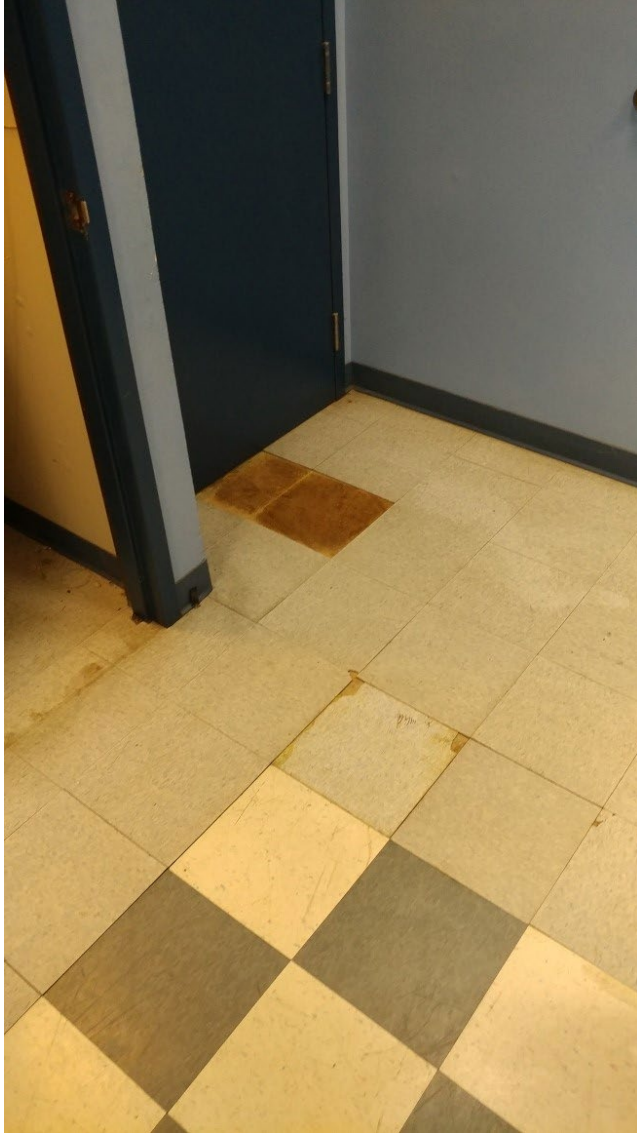
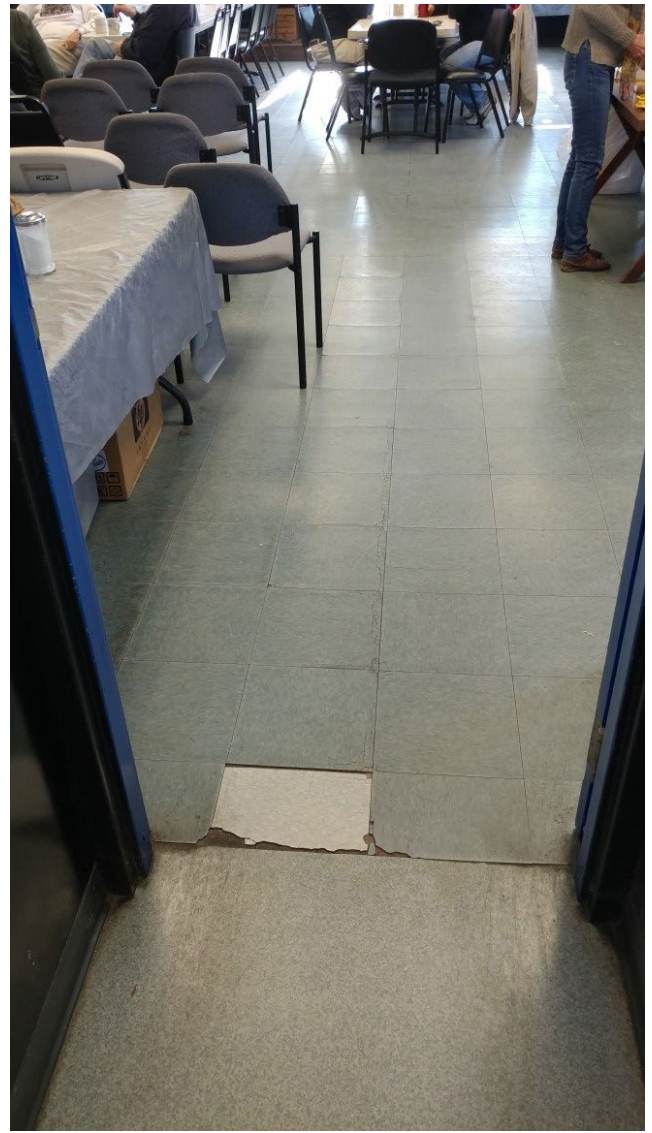
Regarding finishes, the community center is a well utilized (busy) building that creates significant wear on the finishes, such as flooring, wall surfaces and ceilings. The expected lifespan of a VCT floor is 20-30 years depending on the foot traffic and maintenance schedule. Many of the floors at the community center are 15 years old and starting to show signs of wear or have chipped tiles.

**CHIPPED AND DAMAGED FLOOR TILES**

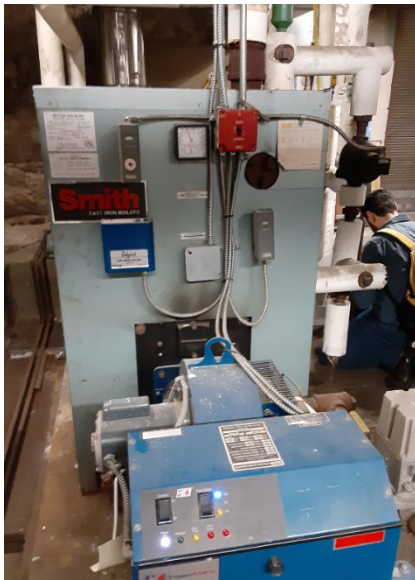
Heating Plant

The building is heated by a gas fired, Smith boiler with a capacity of 1342 mbh, currently located in the basement mechanical room. The boiler was installed in 1999. A typical expected useful life of a cast iron, gas fired boiler is approximately 35 years. The vast majority of the building is heated using perimeter base board radiation. The hot water distribution piping serving the building is likely at least 40 years old and well past its expected useful lifespan however there have been no leaks reported.

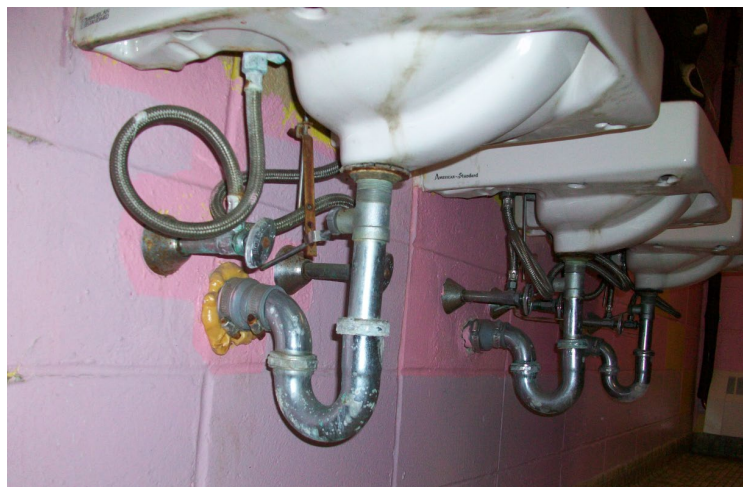
Lavatories in the Restroom annex without ADA insulation

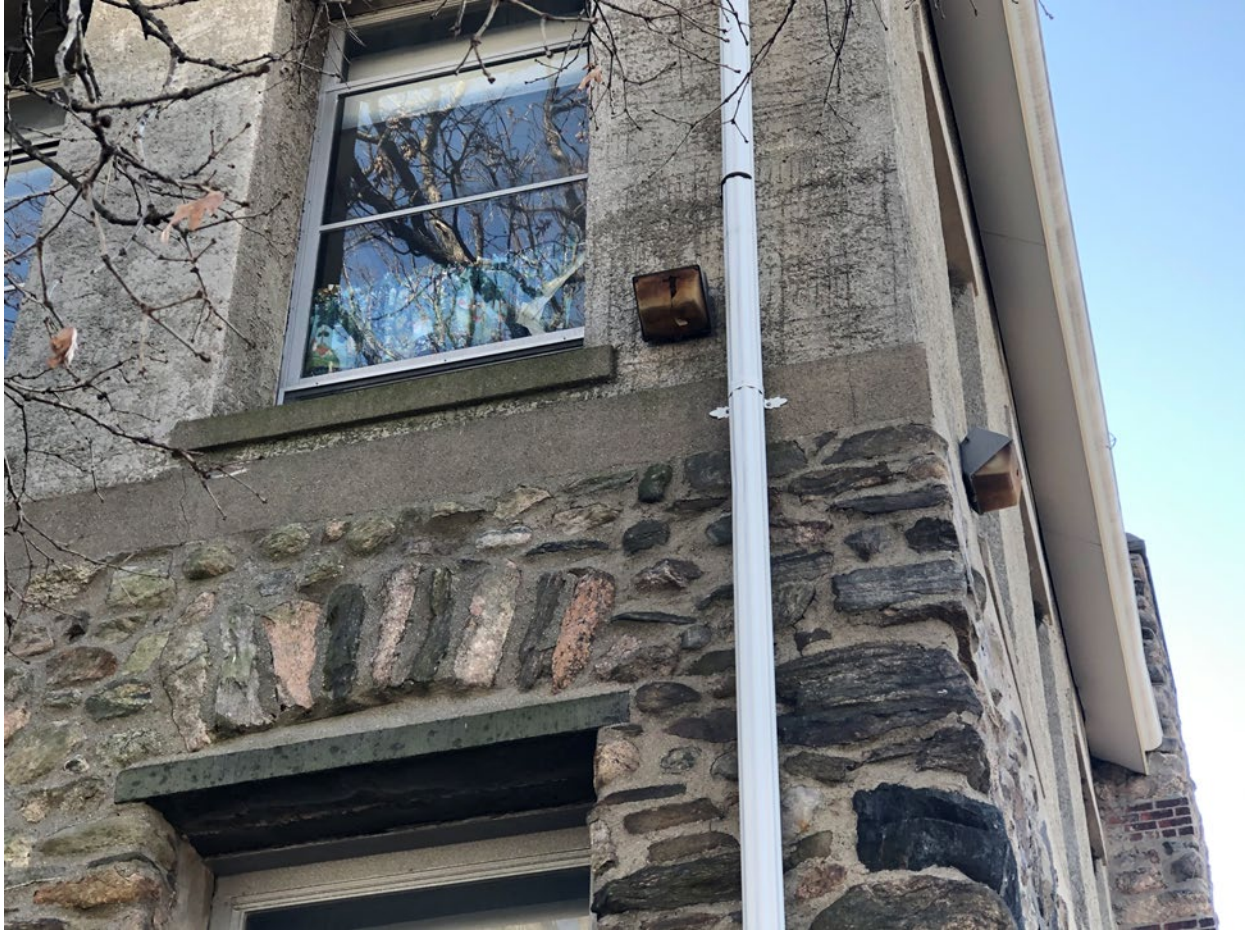
The existing building mounted lighting is old and most of the fixtures are damaged. It was not possible to determine if all fixtures were in working order. Most of the area lights had broken lens and lenses were yellowed from age and are no longer efficient.

Damaged exterior area light fixture

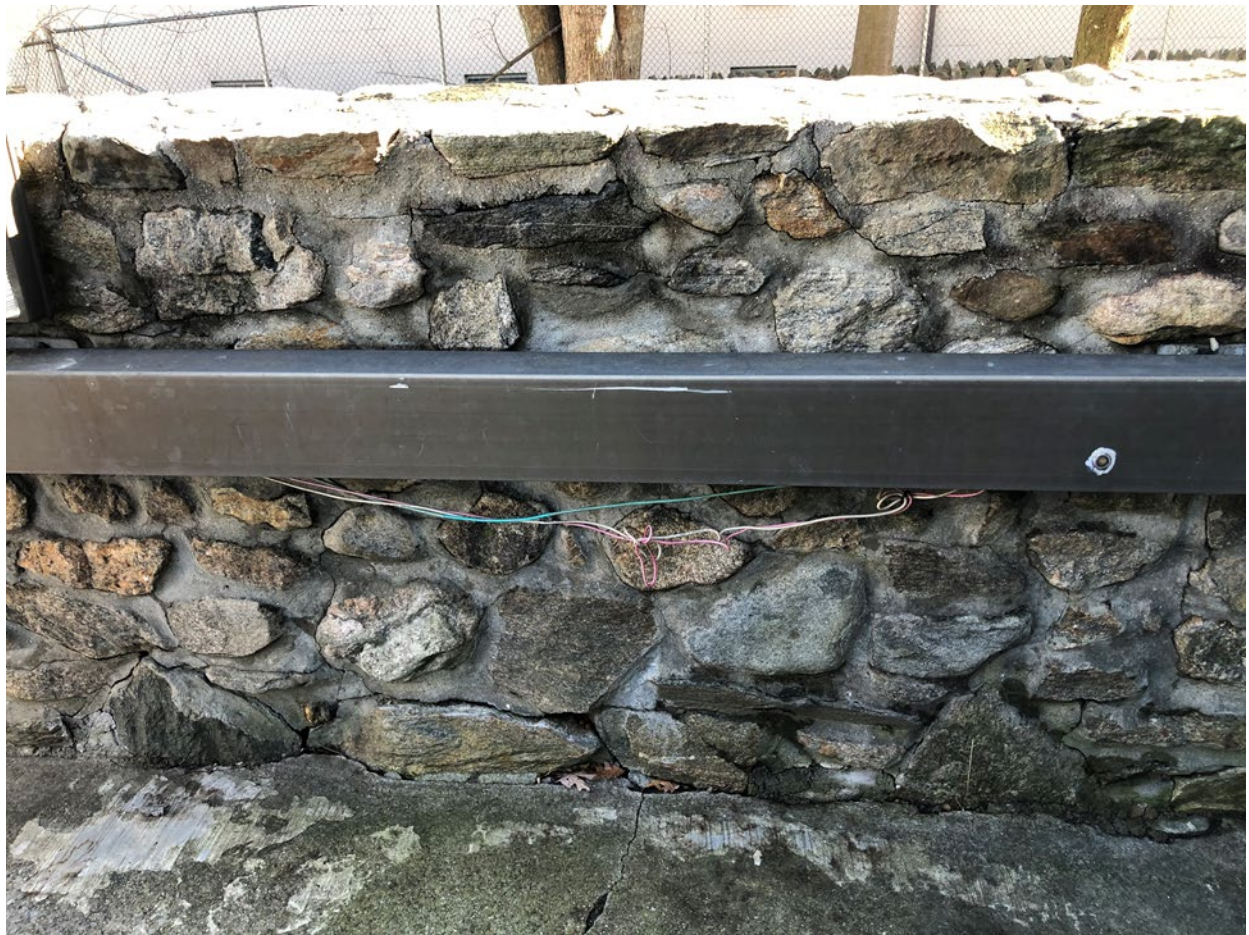
Exposed wiring in ramp handrail

- Emergency lighting should be installed in all of the rooms.
- Call for aid systems should be installed in the single toilet rooms, with the exception of the toilet rooms, which are monitored by the users.
- Existing interior fluorescent light fixtures should be removed and replaced with new energy efficient LED fixtures. An alternate would be to replace just the lamps with retrofit LED lamps.
- Existing exterior building light fixtures should be removed and replaced with new vandal resistant, energy efficient LED wall fixtures.
- Remove and replace walkway light fixtures with new energy efficient LED fixtures and add fixtures to provide the required illumination levels.
- Remove and replace existing pathway lighting with new LED fixtures.
- Remove existing incandescent gymnasium downlights.
- Repair exposed wiring in ramp handrail.
