Re: Main Street Bridge over the Rippowam River - Pedestrian Upgrade & Walkway Report
WMC reference No. 18048

2002 Existing Bridge Photographs
Main Street over Rippowam River (Bridge No. 02212)
Stamford, CT

2010 Existing Bridge Photographs (April 6, 2010)
Main Street over Rippowam River (Bridge No. 02212)
Stamford, CT

2018 Existing Bridge Photographs (April 5, 2018)
Main Street over Rippowam River (Bridge No. 02212)
Stamford, CT

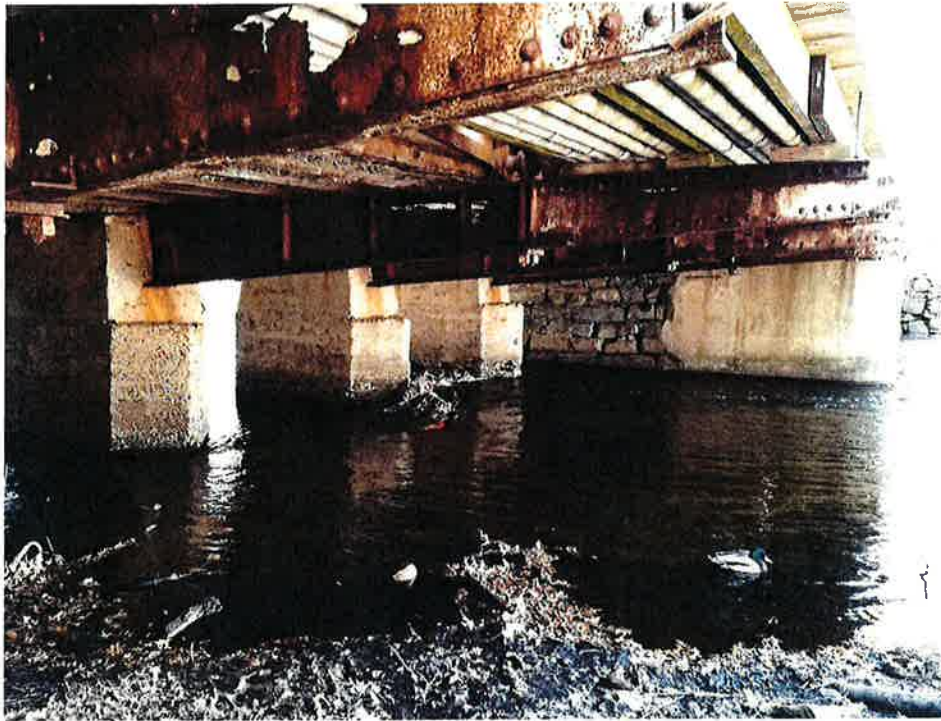
- The lenticular trusses and bridge deck are in fair condition. Deterioration/damage was noted and repairs are required, but these components are serviceable.
- The steel superstructure has failed or is failing (see photo 1).
 - In general, the floor beams outboard of the lenticular trusses have failed and are unsafe, which is why the sidewalks have been closed. Note that the utilities on the upstream and downstream sides are supported on this area of the floor beams.
 - Inboard of the trusses, the floor beams are in poor condition, and repairs are urgently required. The floor beams are supported by concrete piers at each floor beam, which is likely why the superstructure has not completely failed. The condition of the floor beams within the concrete piers could not be determined.

Photo 1: Underside of Bridge showing Floor Beams, Piers, and Utilities (typical)

1. Limit the available travel width to reduce the overall load to the structure, and locate the travel path over the concrete piers at the center of the bridge.
2. Perform repairs to the floor beams inboard of the trusses, including new steel web plates to replace deteriorated panels (see photo 1 and photo 2) and replacing failed rivets with high-strength bolts.
3. Perform repairs to the lenticular trusses, including replacing the cover plates at all top chord panel points (see photo 3), repairing truss end posts, replacing several hangers at the floor beams (see photo 2), and replacing bottom chord plates to maintain truss stability.
4. Relocate the utilities to floor beams inboard of the trusses. This will require removal of portions of the bridge deck. Remove the failed floor beams outboard of the trusses after the utilities have been relocated.

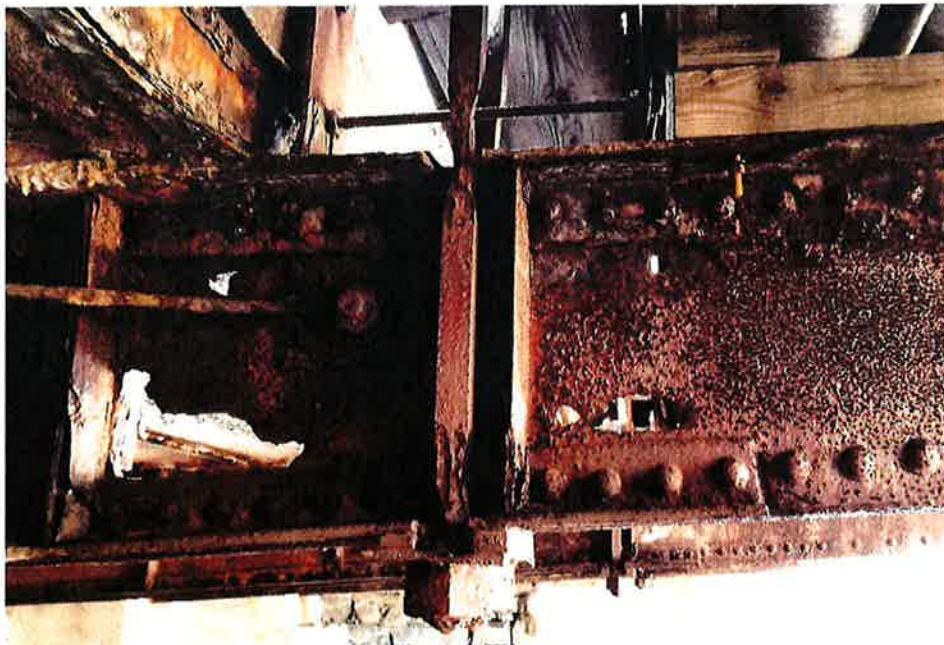
Photo 2: Floor Beam at Truss Hanger (outboard to right)

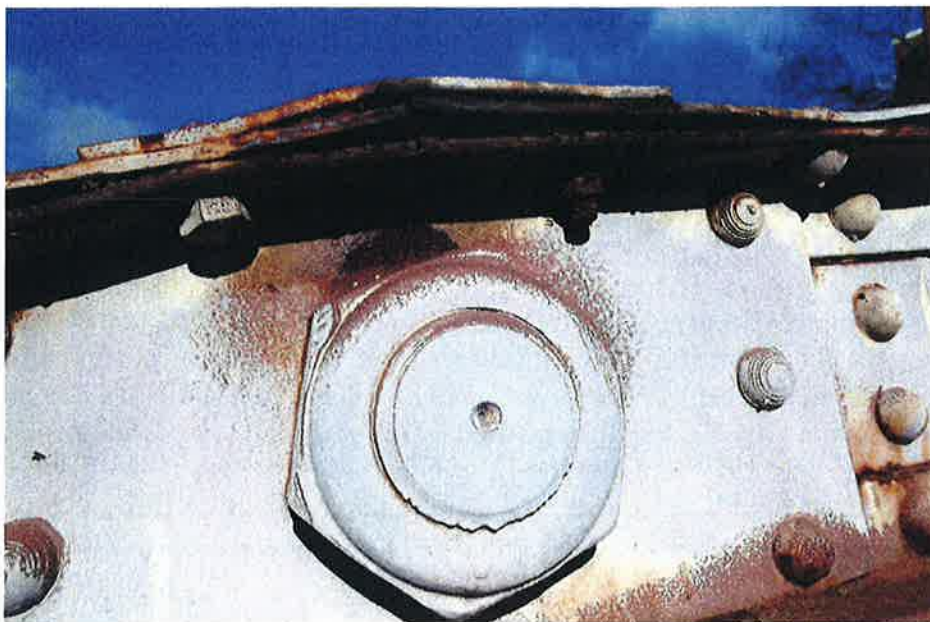
Photo 3: Cover Plate at Lenticular Truss Top Chord Panel Point (Typical)

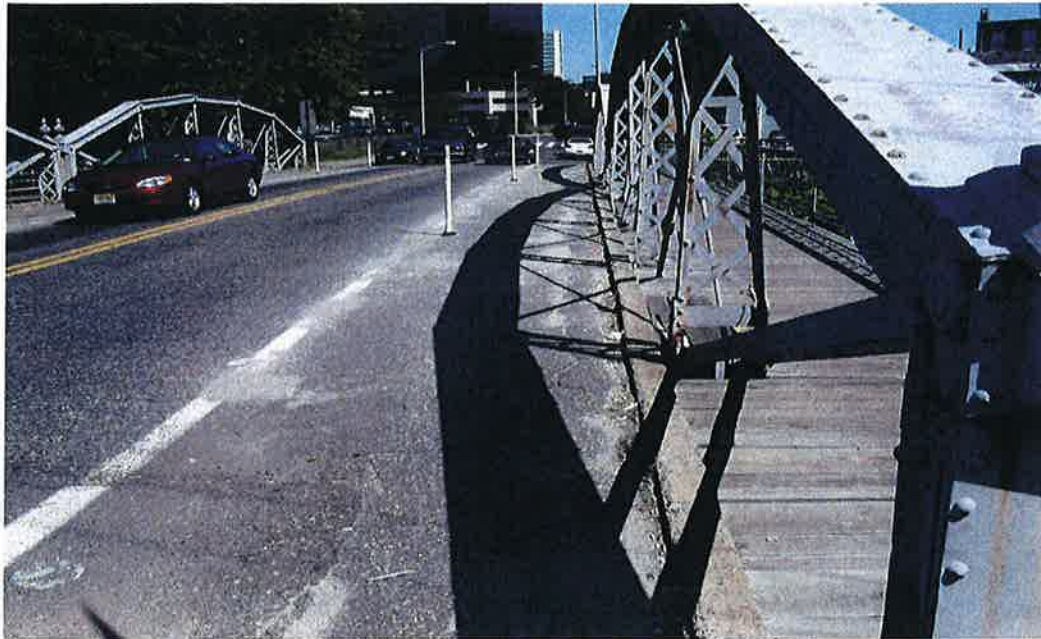
Photo #1 – Roadway and South Truss – Looking East

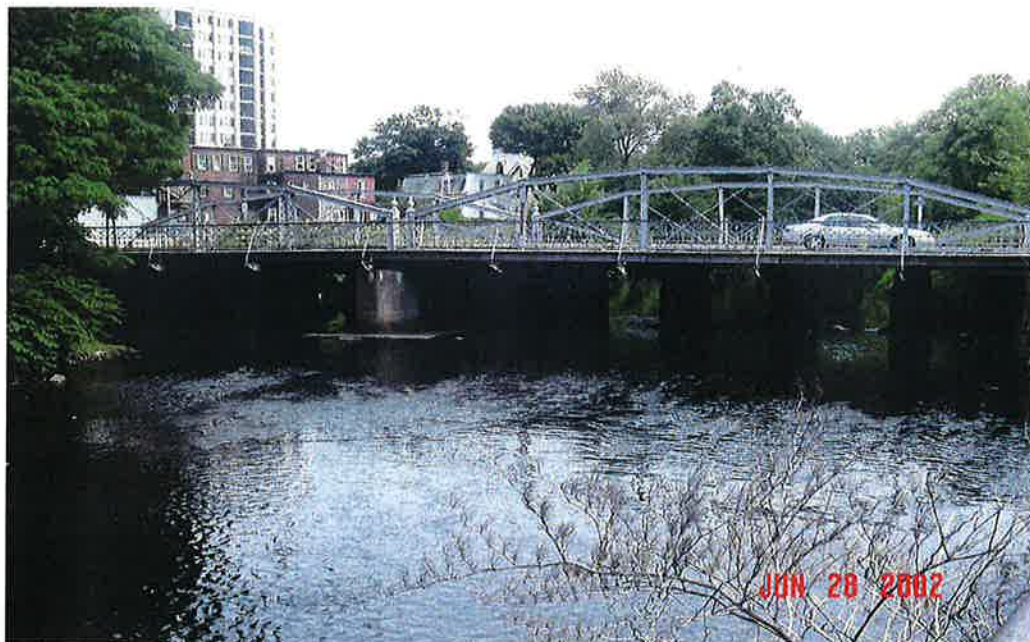
Photo #2 – North (Upstream) Elevation View

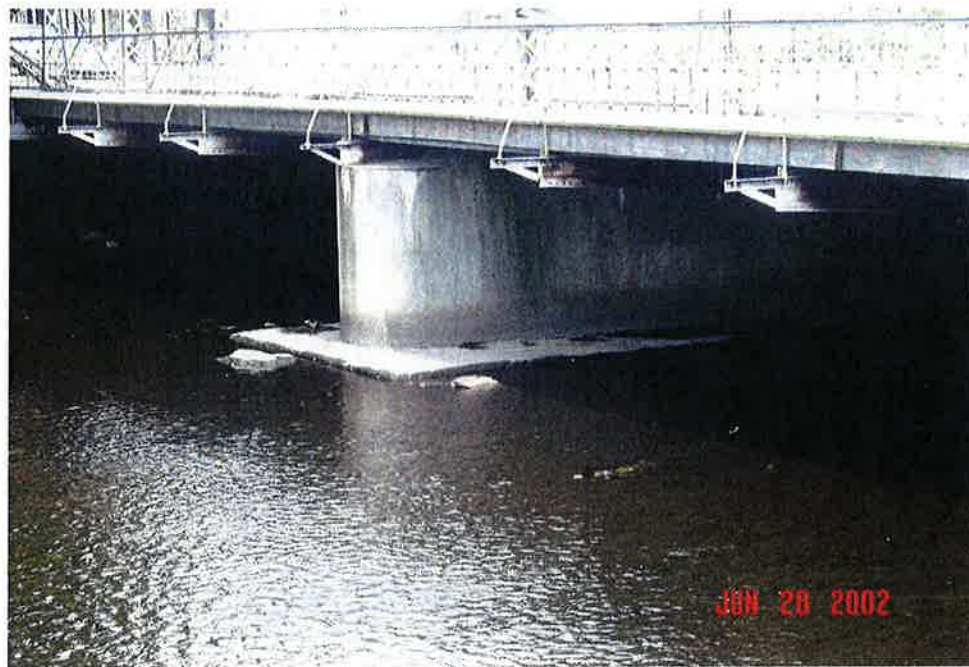
Photo #3 - Upstream End of Main Pier

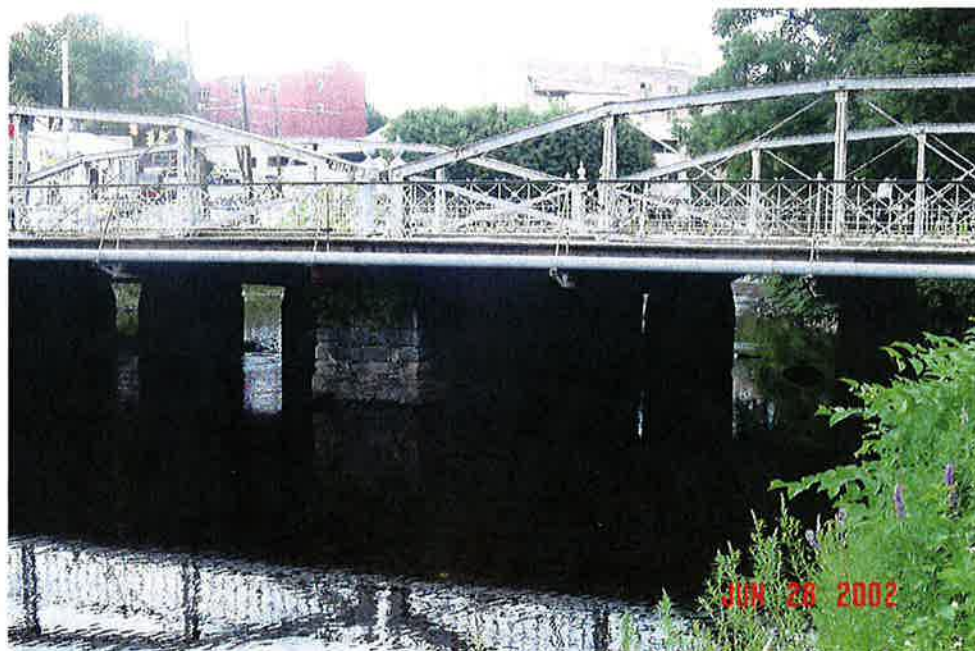
Photo #4 – Downstream End of Main Pier

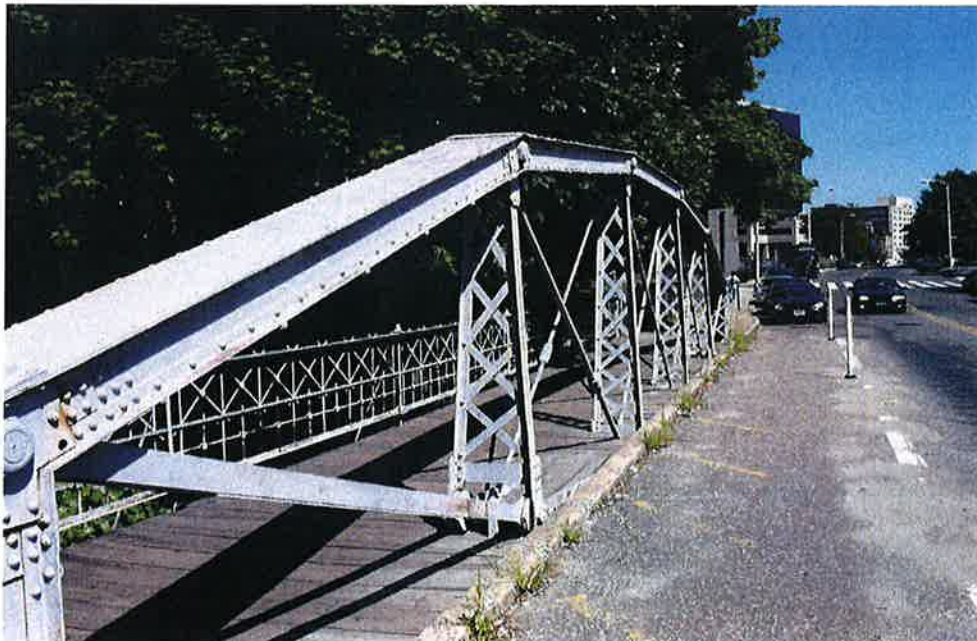
Photo #6 – North Truss and Sidewalk

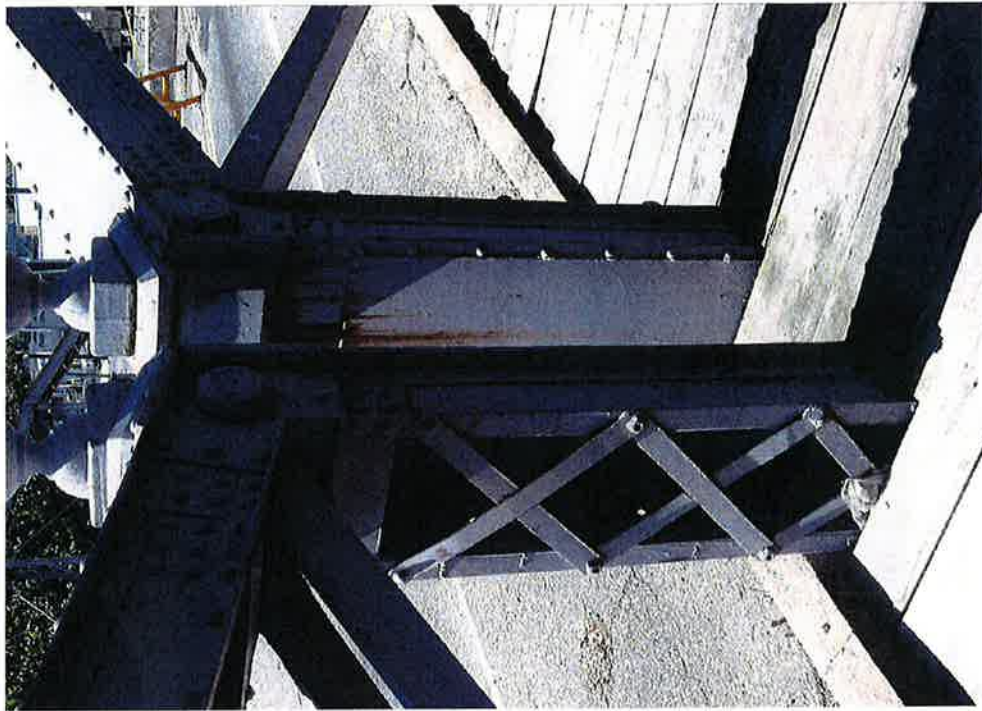
Photo #75 – Typical Truss Post Condition

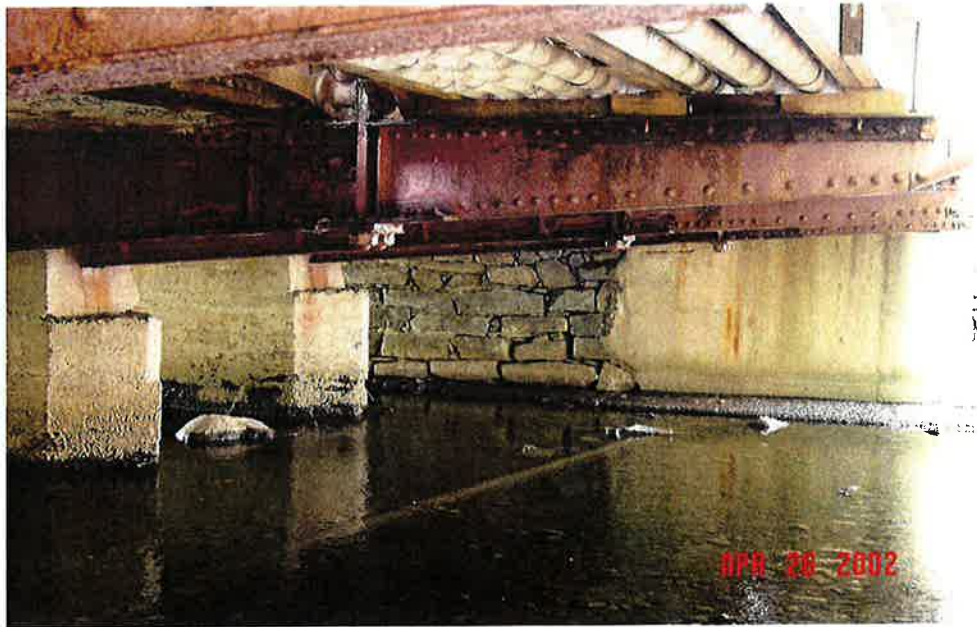
Photo #8 – Typical Floor Beam Condition

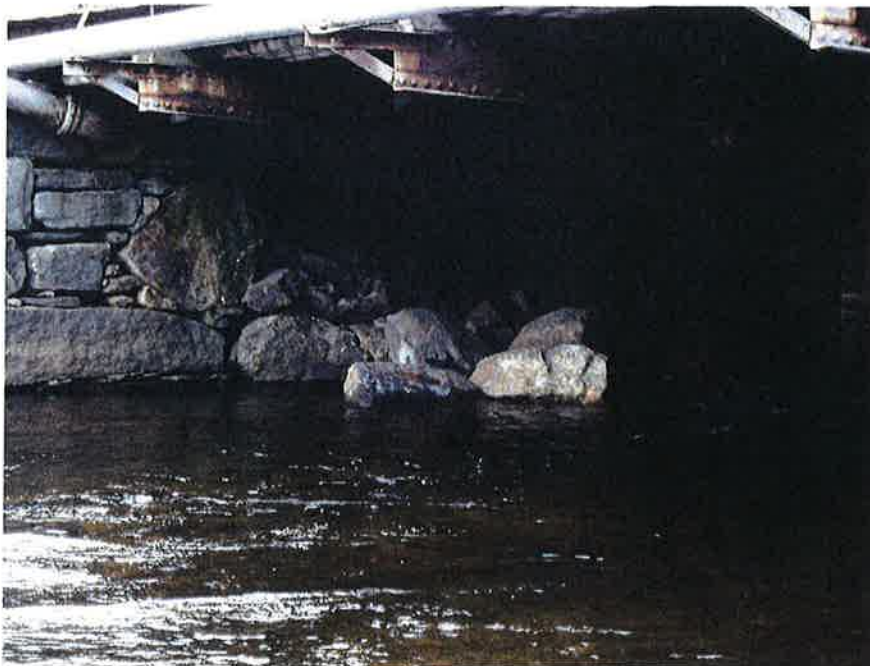
Photo #1 – West Abutment - Note Very Large Void

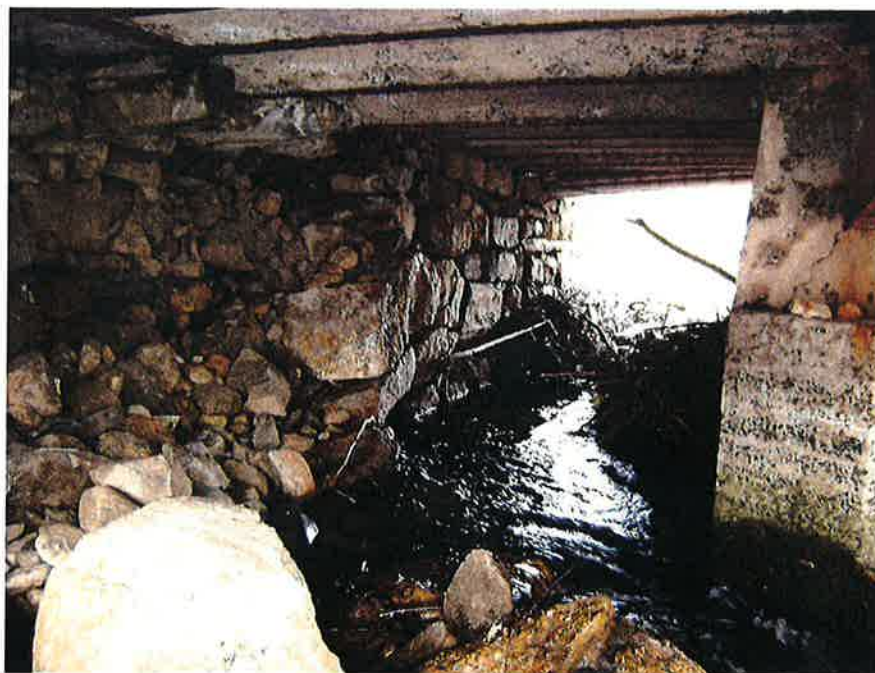
Photo #2 – West Abutment - Note Very Large Void & Large Amount of Debris Upstream

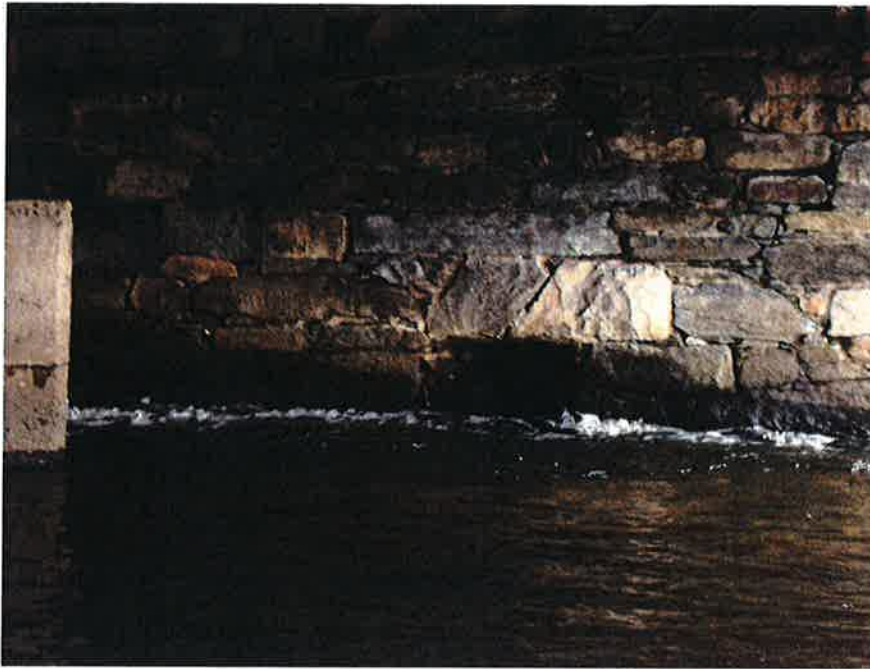
Photo #5 - Main Pier (West Elevation) - Note Approx. 3' Wide by 2' High by 2' Deep Void

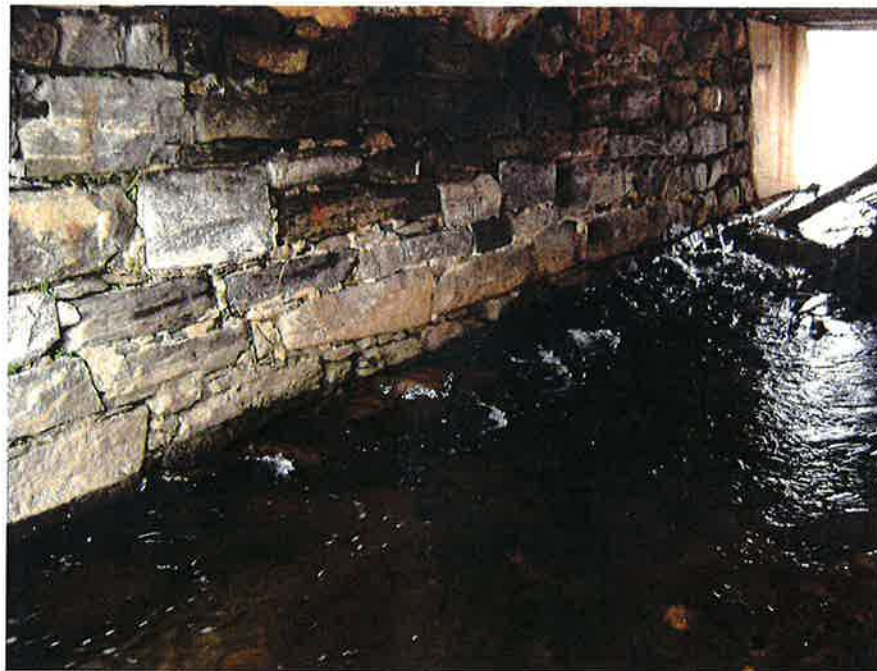
Photo #6 - Main Pier (East Elevation) - Note Debris Just Upstream

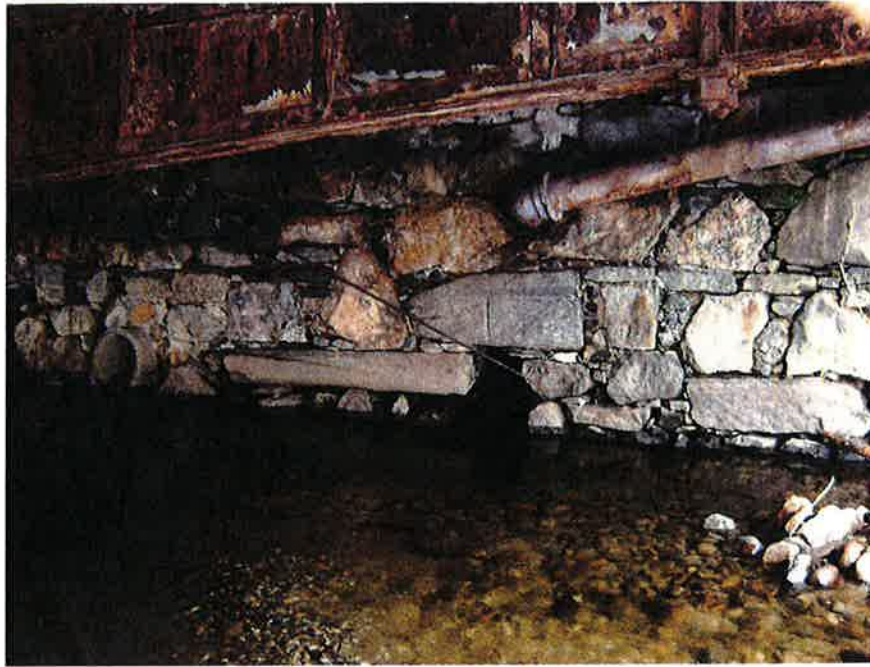
Photo #7 – East Abutment - Note Approx. 2' Wide by 3' High by 6' Deep Void

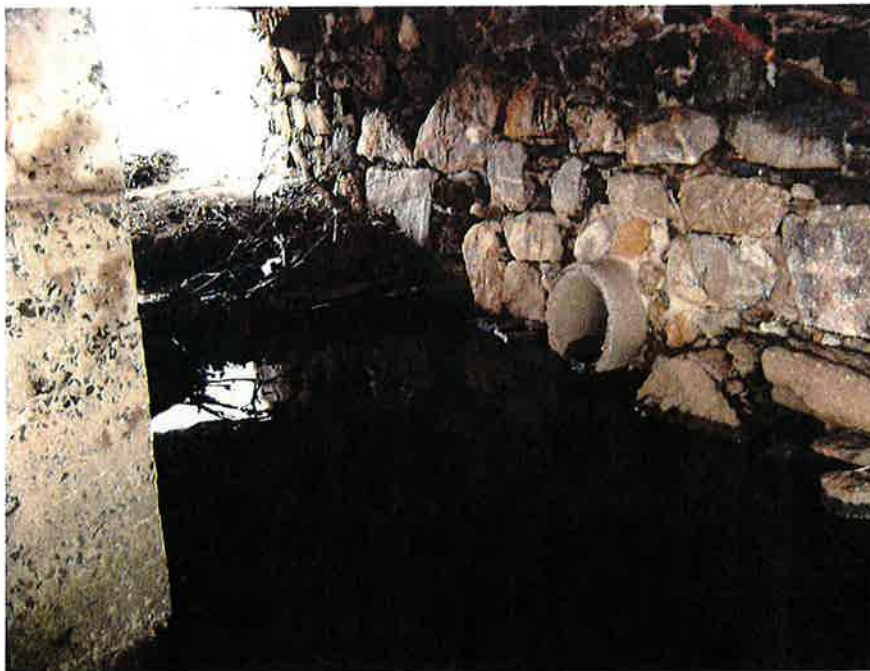
Photo #8 – East Abutment - Note Large Amount of Debris Just Upstream

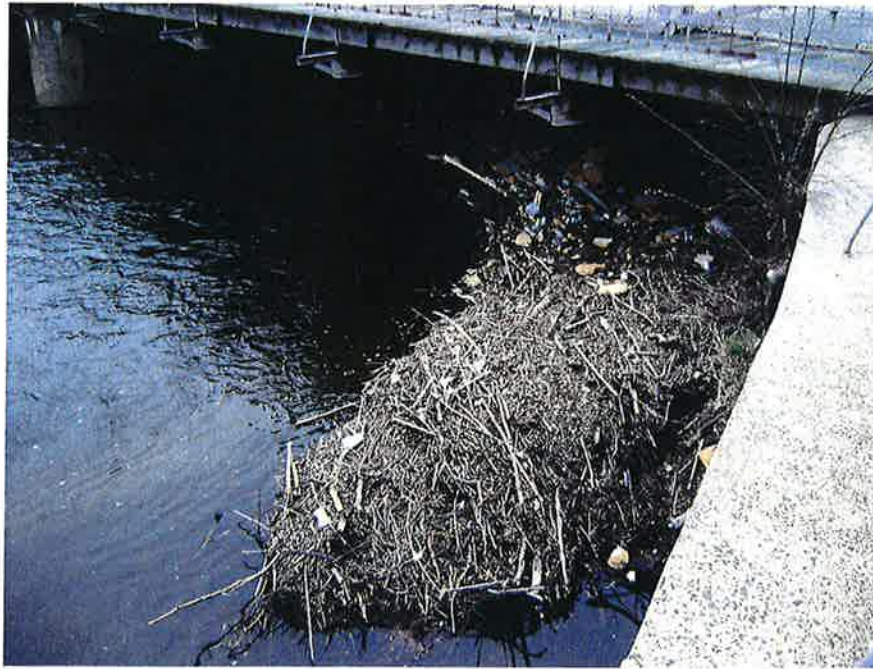
Photo #9 – Upstream of Bridge Near West Abutment - Note Very Large Amounts of Debris

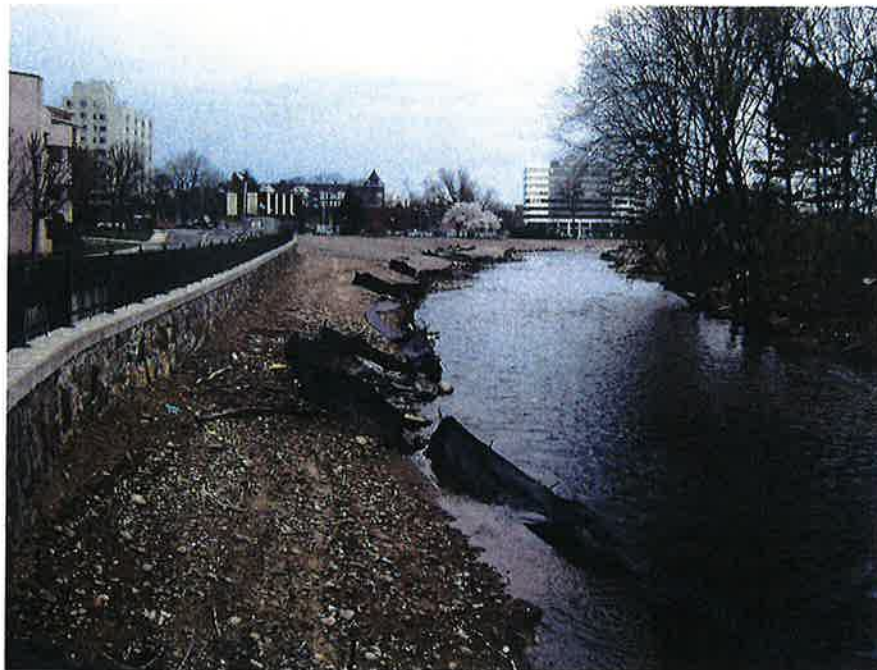
Photo #10 – Mill River - Looking Upstream from Bridge

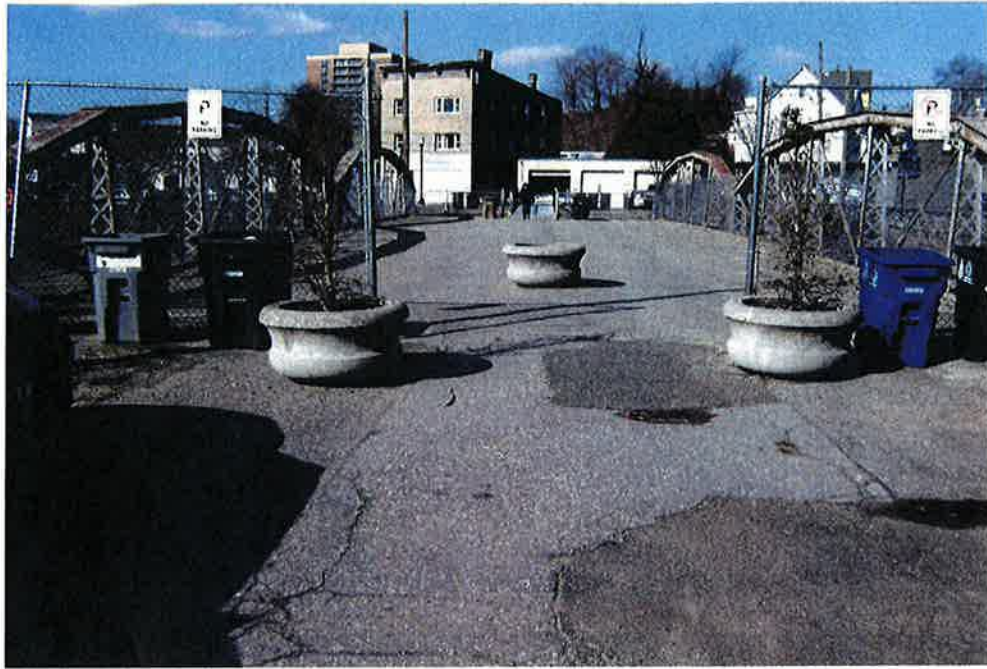
Photo #1 – Bridge Deck Looking West - Note Overall Rusting of Trusses

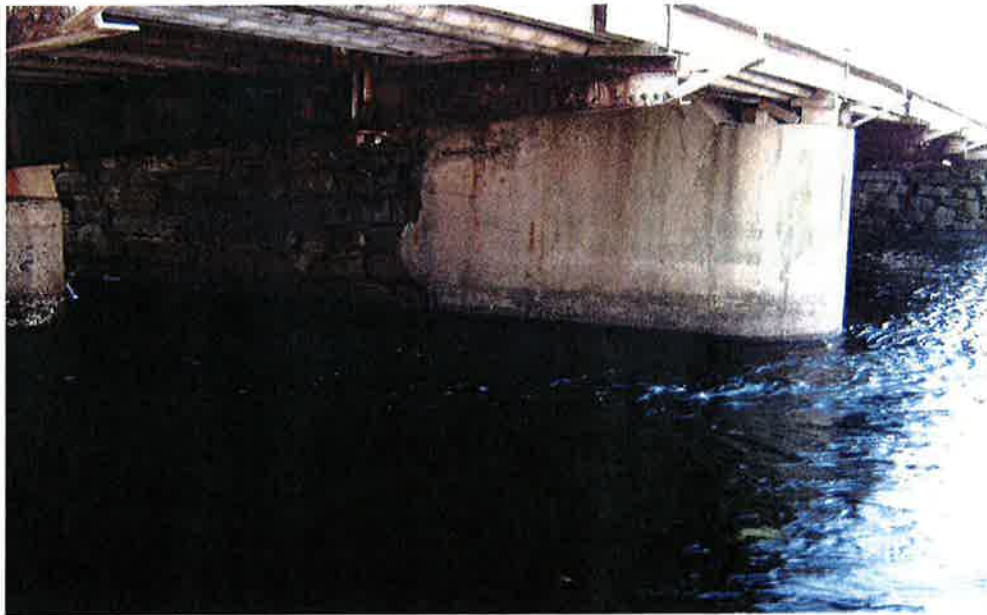
Photo #2 – Upstream End Main Pier – Also Note Rusting & Holes in Floor Beam

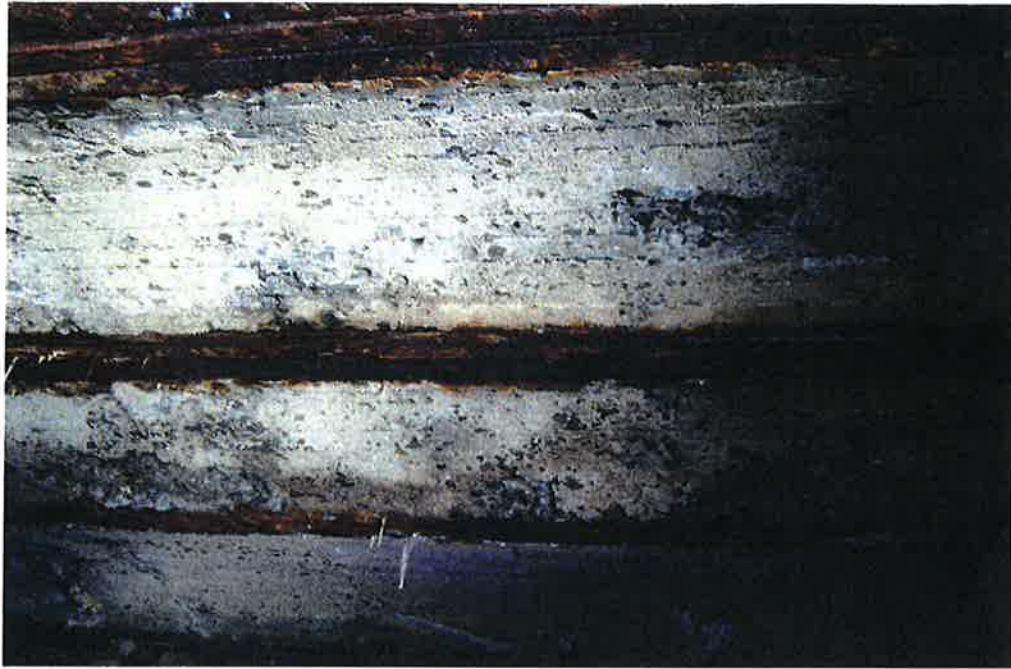
Photo #3 – Typical Underside of East Span – Note Rusting Stringers

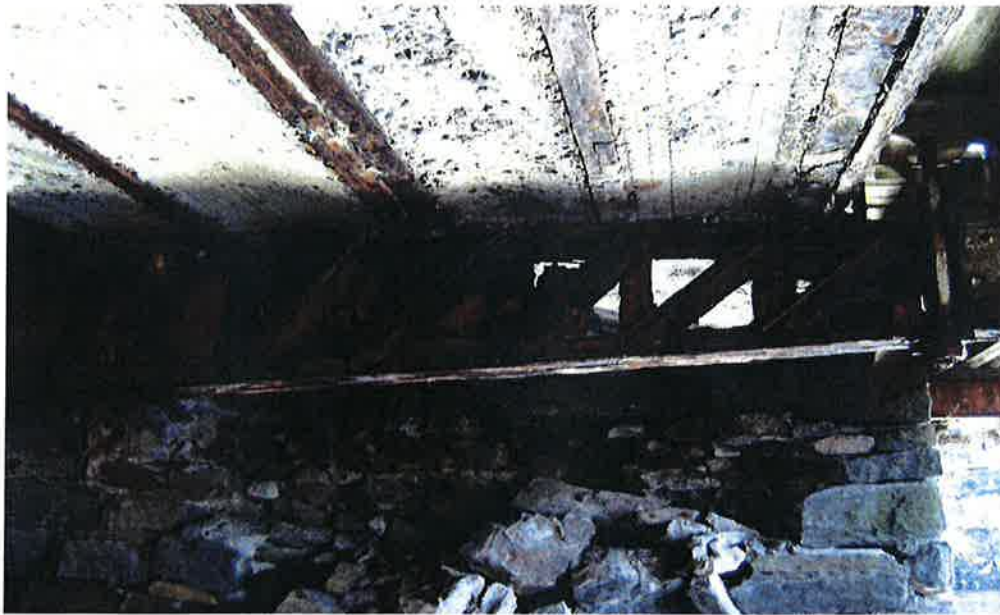
Photo #4 – Typical Underside of West Span – Note Poor Floor Beam Condition

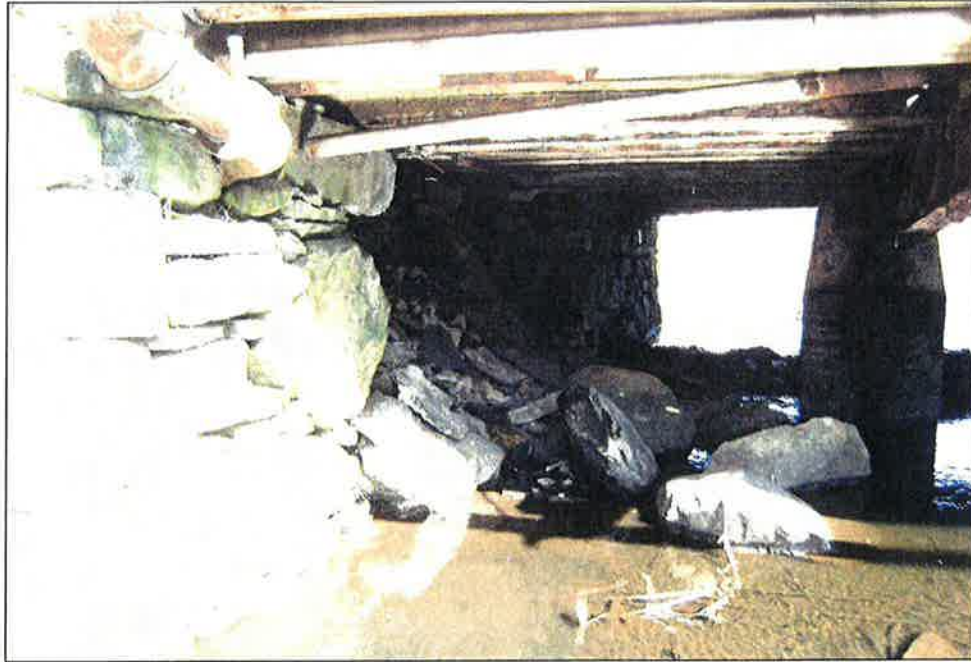
Photo #5 – West Abutment Failure From Downstream

Before the walkway work can be implemented however, the existing substructure will need significant work. The west abutment will be repaired by removing the failed section in the middle and replacing it with a new section of reinforced concrete abutment and then making limited repairs and re-aligning the salvageable portions of the existing stone masonry abutments

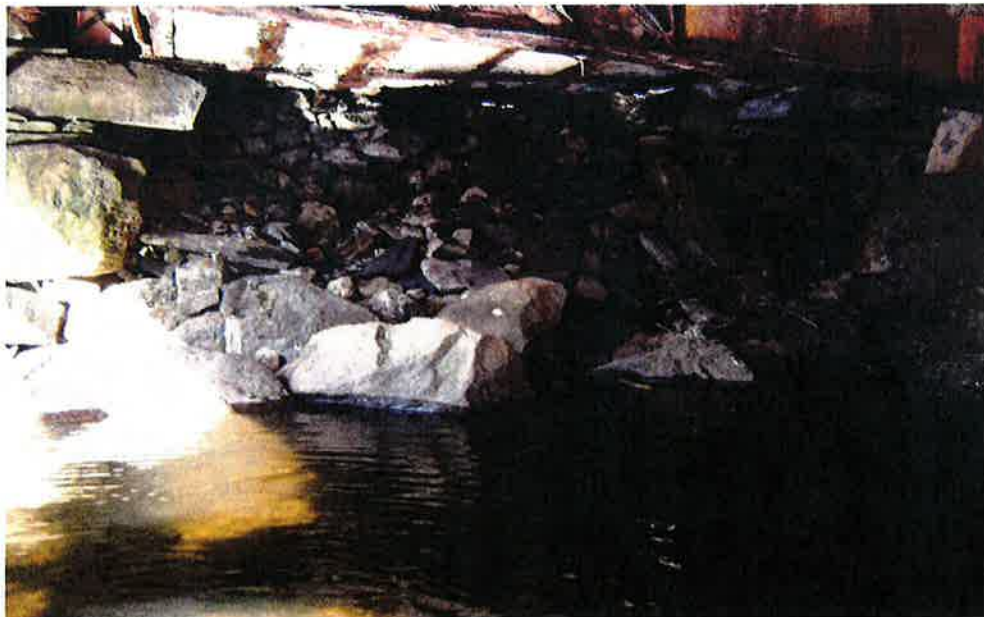
Photo #6 – West Abutment Failure (20' wide x 9' deep x 7' High)

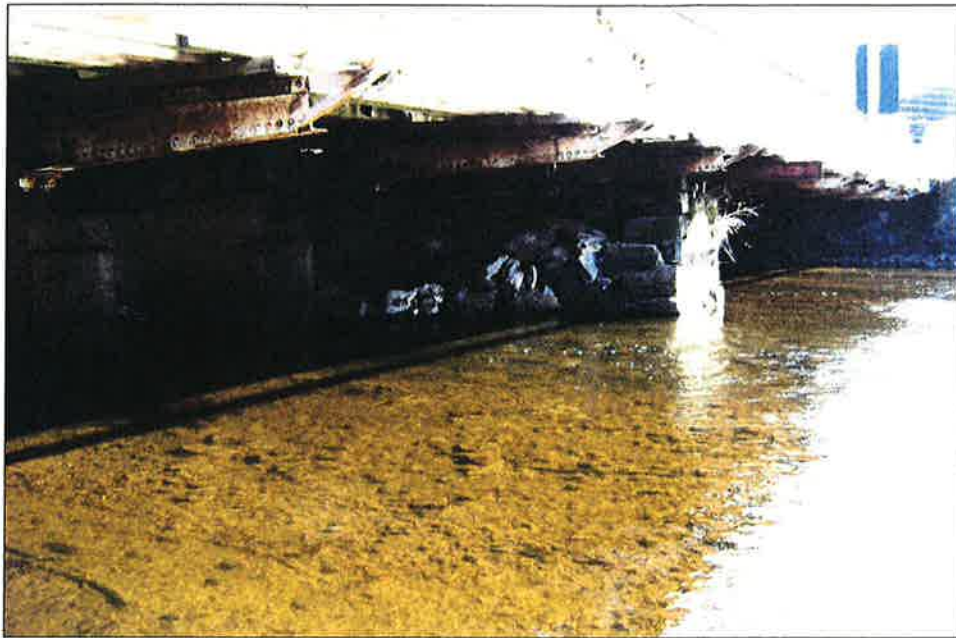
Photo #7 – Main Pier Collapse Downstream End (West Side). Note Floor Beams

to either side. The stone masonry (failed section) portion of the center pier will be completely removed and replaced with a reinforced concrete pier essentially matching the existing concrete pier section (which will be retained). As with the west abutment, the footings for the repaired section of pier will essentially match the elevation and width of the existing substructure element. The east abutment will be retained in its entirety, with minor modifications and repairs. All remaining stone masonry will then be re-chinked and repointed.

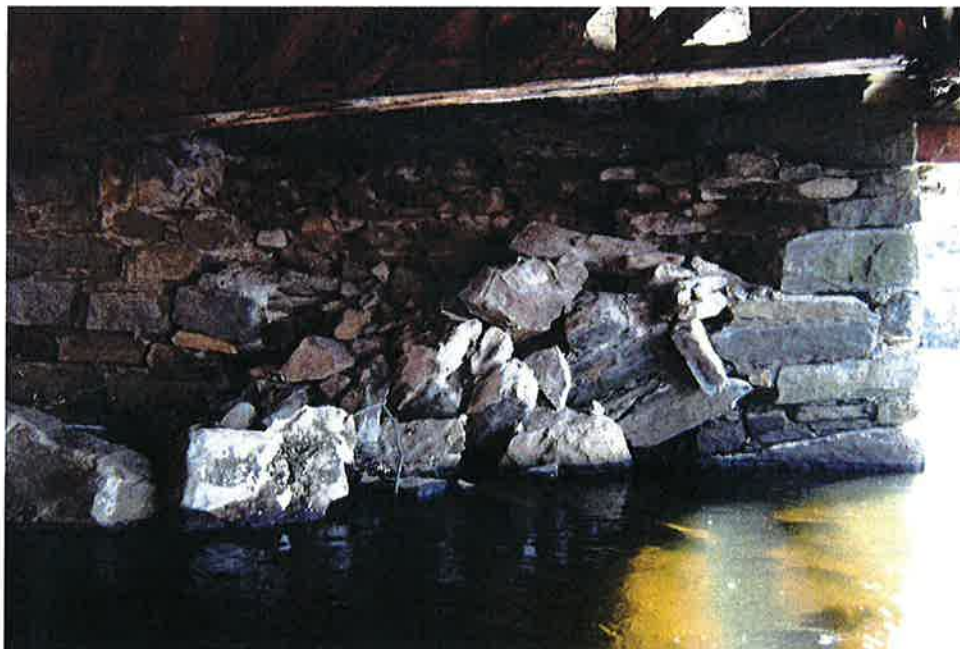
Photo #8 – Close-Up Main Pier Collapse. Also note Hole in Floor Beam.

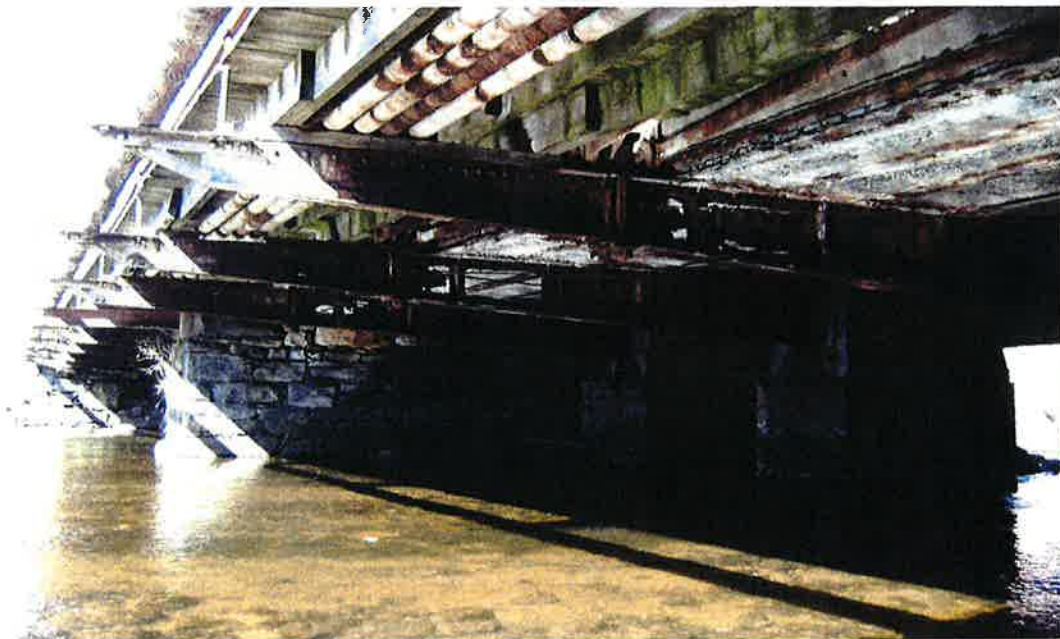
Photo #9 – Downstream East Span Floor Beams. Note Intact East Side of Main Pier.

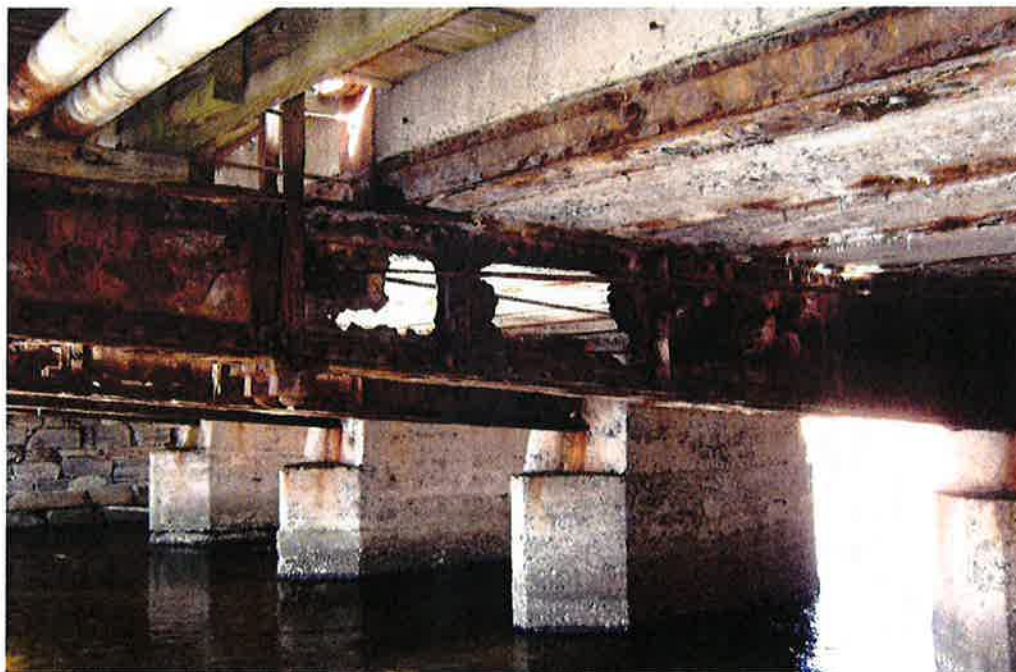
Photo #10 – Close-Up of Deterioration of Downstream East Span Floor Beams.
