August 20, 2021

Louis Casolo, P.E.  
City Engineer, City of Stamford  
Engineering Department  
Stamford Government Center  
888 Washington Boulevard, 7<sup>th</sup> Floor  
Stamford, Connecticut 06901-2024

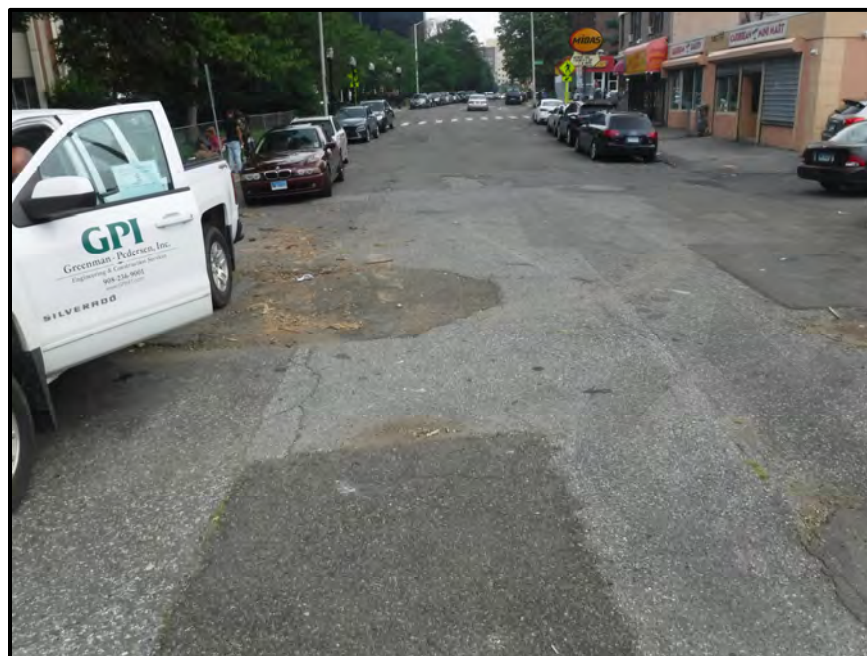
**Photo 4:** General view of East Approach looking east. Note the longitudinal wide cracks and uneven patchwork throughout the asphalt pavement.

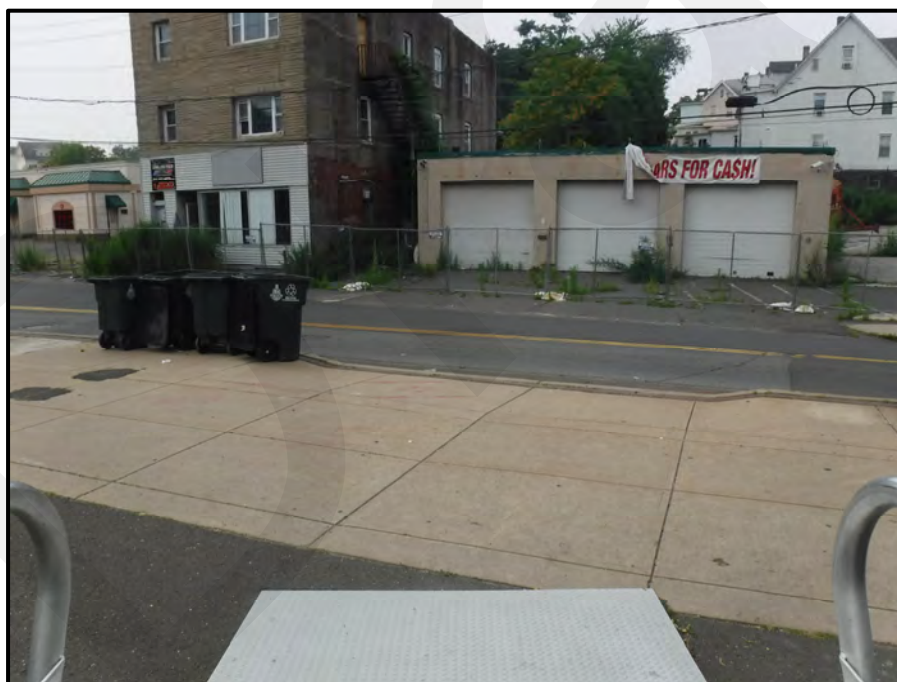
**Photo 5:** General view of West Approach looking west.

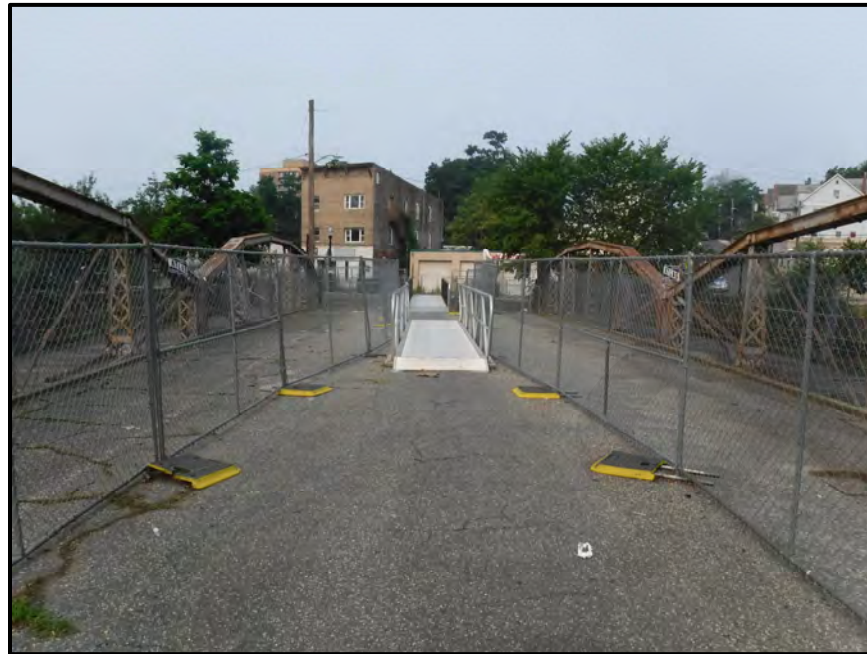
**Photo 6:** General view of Top of Deck looking west from Span 2. Note the widespread longitudinal cracking, mapcracking, and depressions throughout the asphalt pavement.

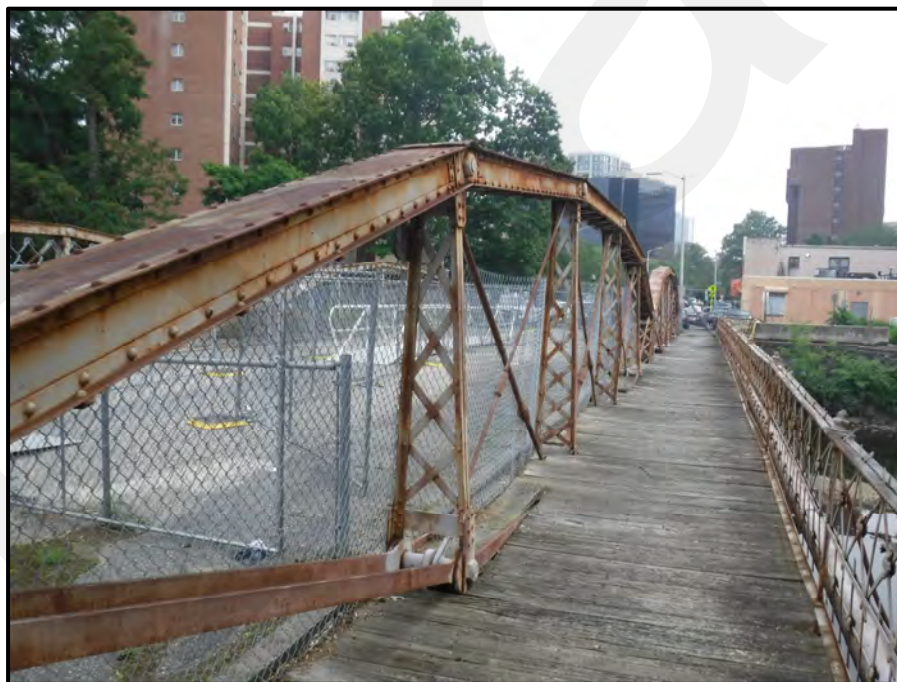
**Photo 7:** General view of the South Truss and closed-off original south pedestrian walkway looking east from the west end. Note the walkway exhibits numerous areas of rotted, loose, and/or broken timber planks and is not suitable for usage.

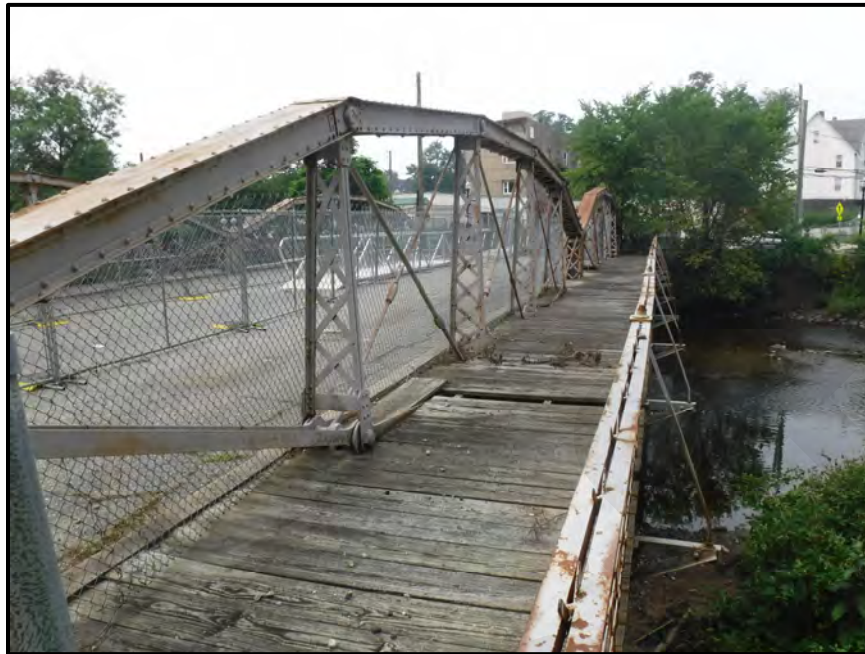
**Photo 8:** General view of the North Truss and closed-off original north pedestrian walkway looking west from the east end. Note the walkway exhibits numerous areas of rotted, loose, and/or broken timber planks and is not suitable for usage.

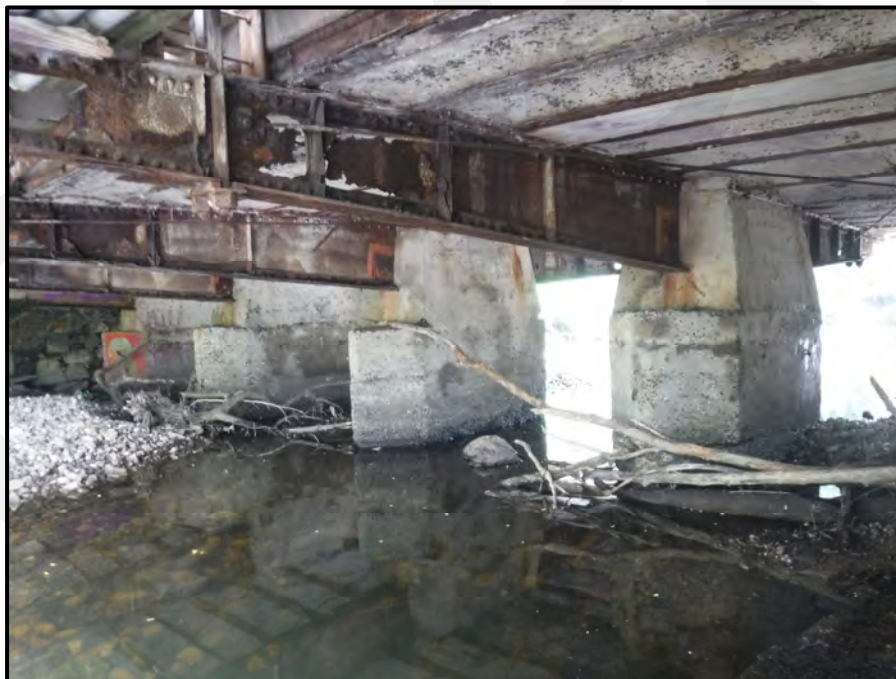
**Photo 9:** General view of the underside of deck, superstructure, and substructure looking southeast toward Spans 6 thru 10. Note the severely deteriorated floorbeams with holed-thru webs. Also note the typical drift and debris accumulation at the piers.

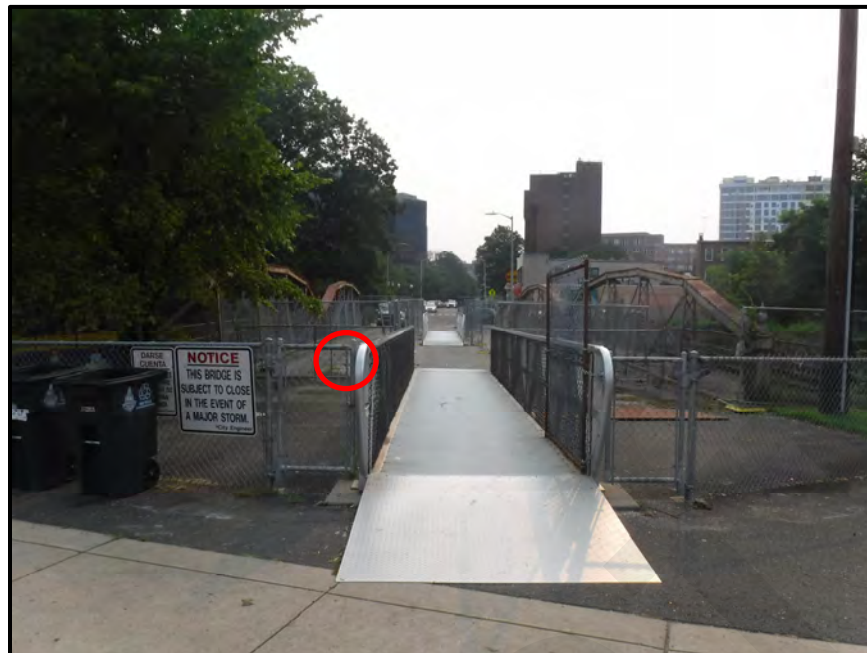
**Photo 10:** General view of the West Gangway (bridges the West Abutment), looking east. Note the gangway is in good condition but is missing one (1) bolt for the hold-down plate at the west end (circled).

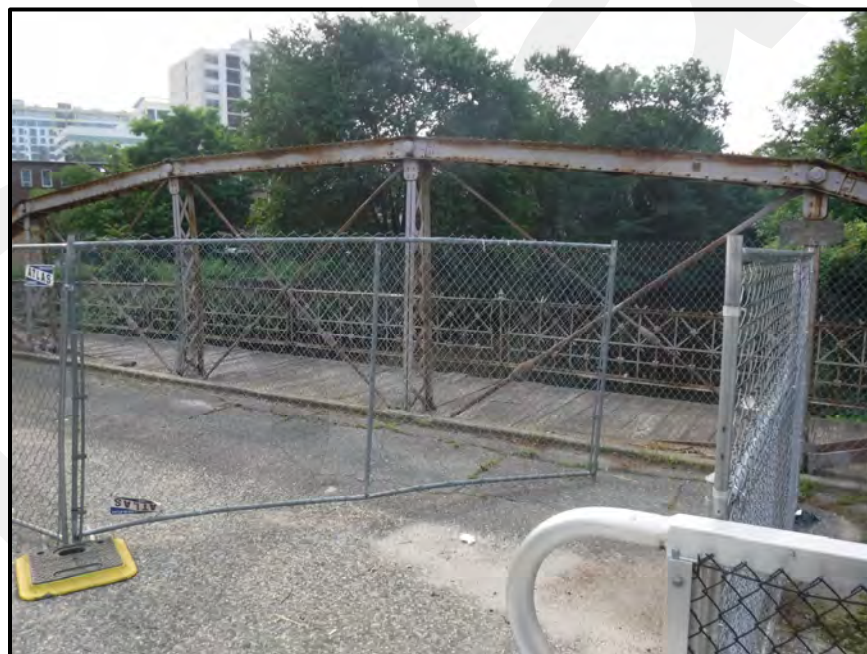
**Photo 11:** Breach in the protective fencing at the west end of the bridge allowing pedestrian access into the closed-off south side of the deck, looking south. Similar breaches are present at several locations throughout the bridge (refer to Appendix C).

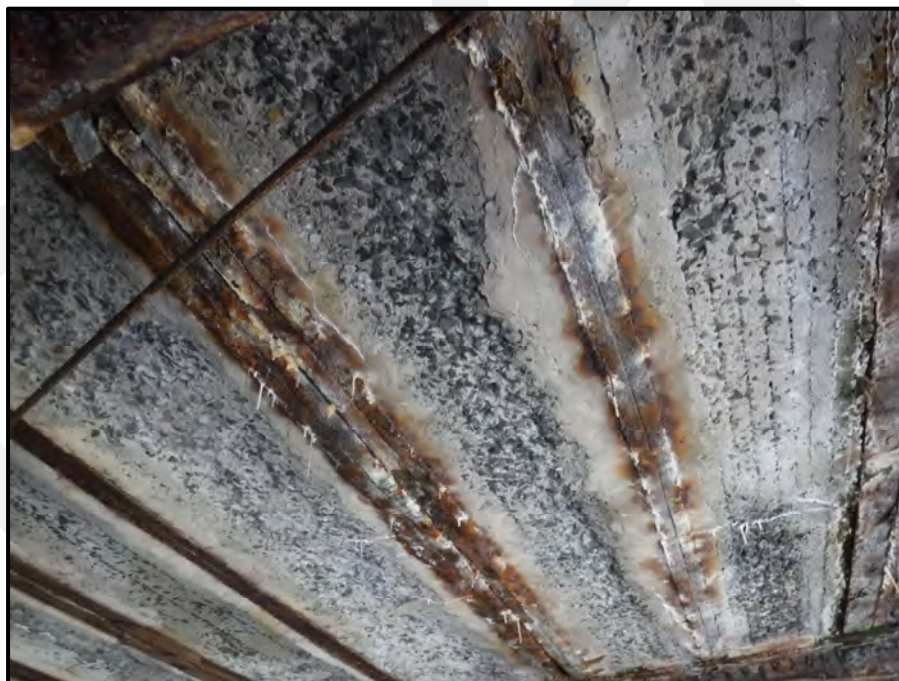
**Photo 13:** Typical widespread scaling with exposed aggregate throughout the underside of the deck in Span 9, looking up, facing east. Note the stringers embedded within the deck exhibit severe deterioration of the exposed flanges.

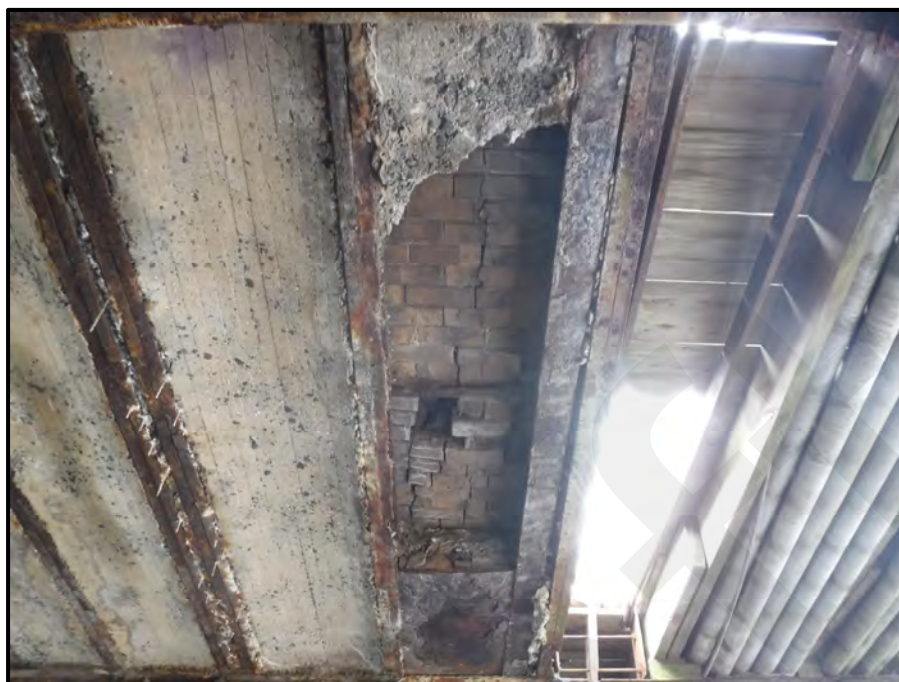
**Photo 14:** 12'± long x 2'± wide area of failed concrete deck with exposed and loose or missing original brick pavers and underside of the asphalt pavement in the north fascia bay in Span 2, looking up, facing west. This condition is outside the limits of the gangways (refer to Appendix B).

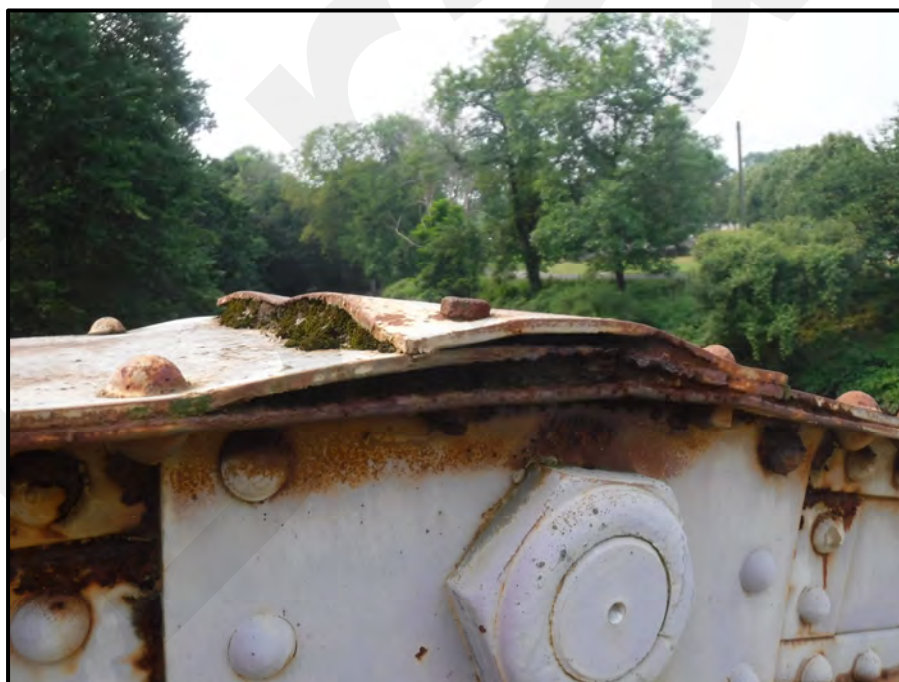
**Photo 15:** Southwest Truss, Panel Point U4 exhibits pack rust (up to 3/4") underneath the upper cover plates, looking southwest. Note the replaced broken rivet. Conditions are typical at all upper panel points.

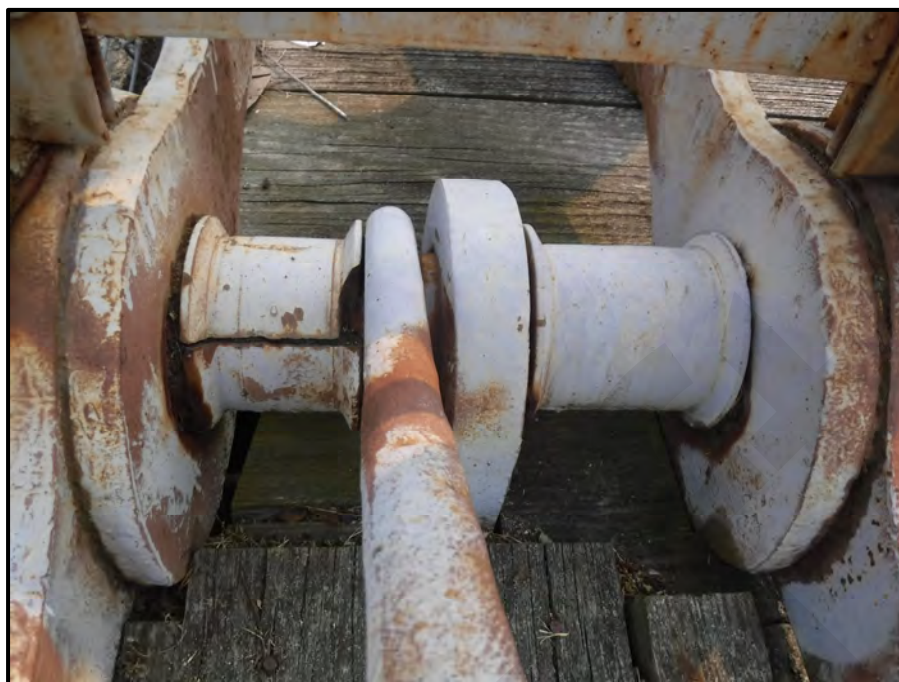
**Photo 16:** Southwest Truss, Panel Point L4 exhibits a broken pin cover / eyebar spacer, looking down, facing west. Condition is typical at numerous eyebars.

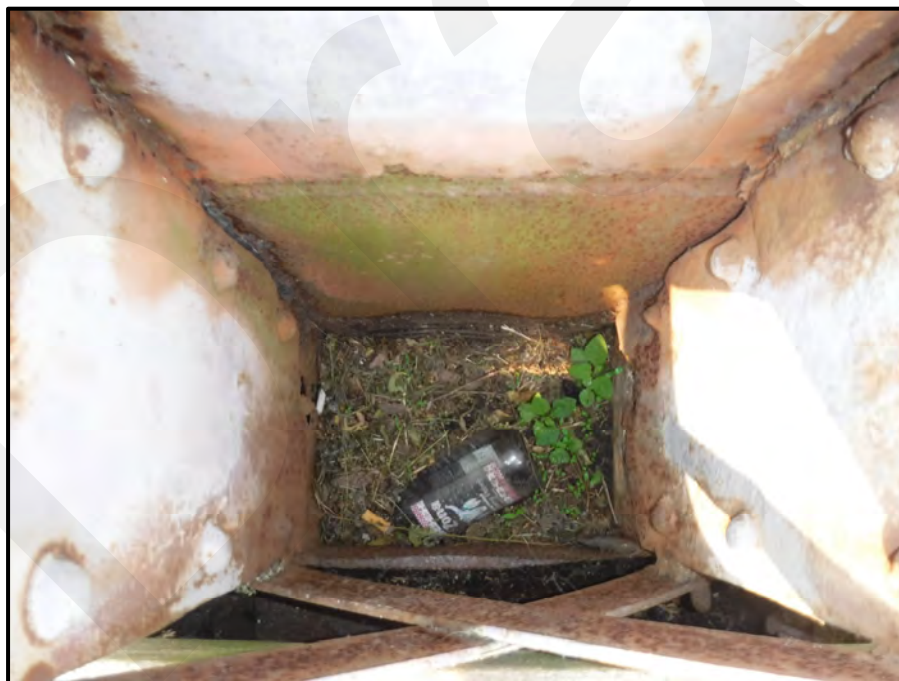
**Photo 17:** Southeast Truss West End Vertical (L0-U0) exhibits severe laminar corrosion with up to 100% section loss throughout the lower 12", looking down, facing east. Note the deteriorating welded repair plate and the debris accumulation at the bottom. Conditions are typical at all end verticals.

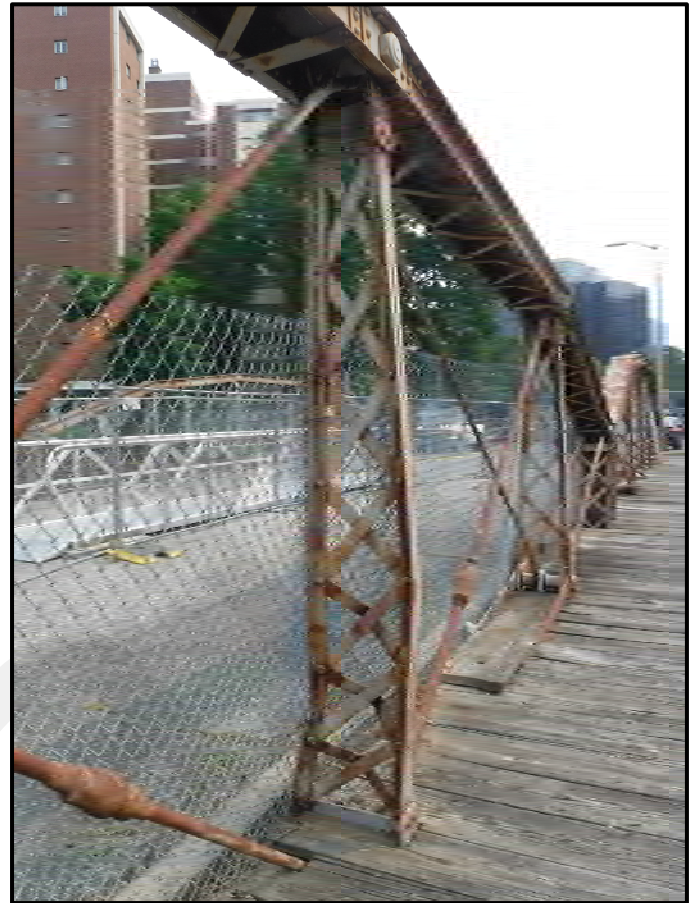
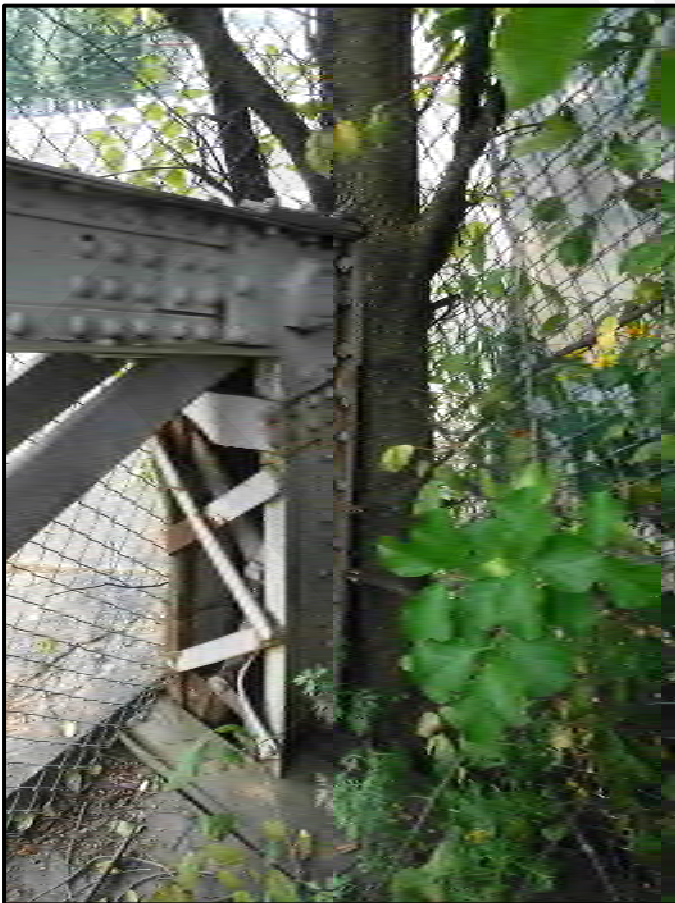
**Photo 19:** Northwest Truss West End Vertical (L0-U0) is severely collision damaged with deformed, broken, and/or detached components, looking southwest. The entire member is bent outward (north) by up to 3", and the upper chord (U0-U1) is also shifted outward up to 3". Note the large tree growing around the vertical which is beginning to push it eastward.

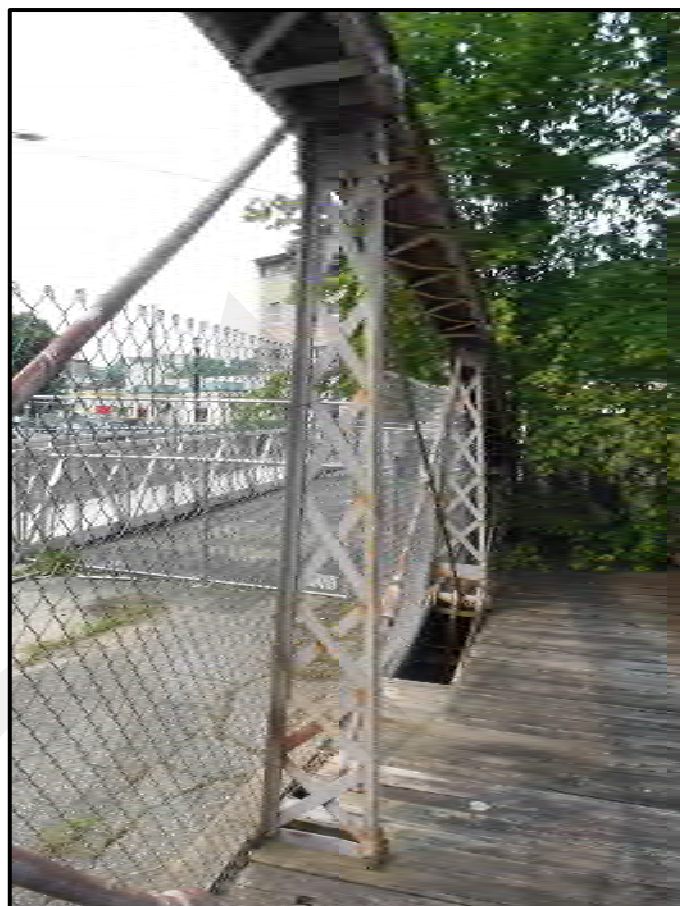
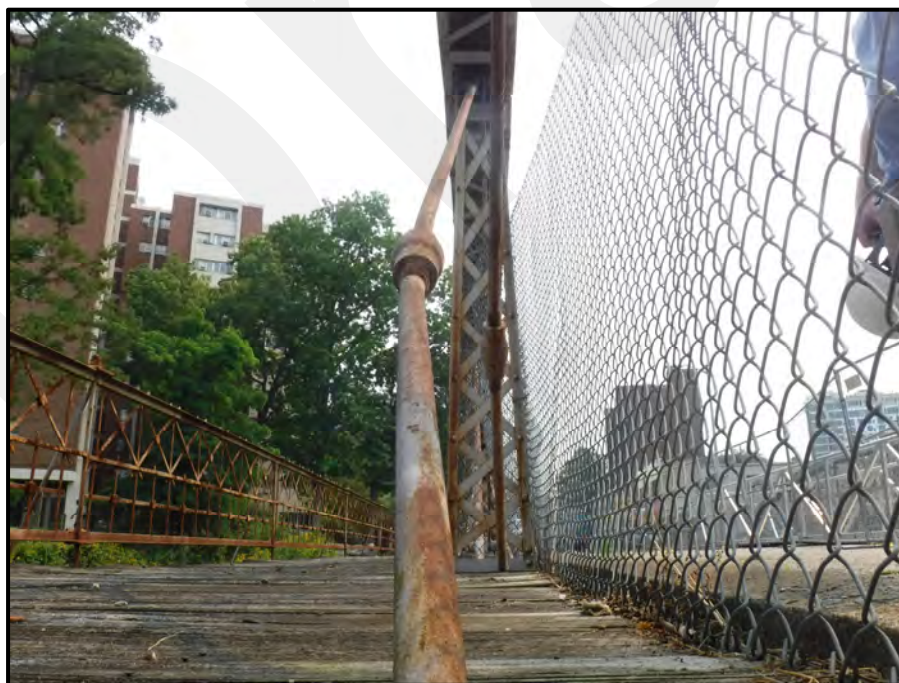
**Photo 21:** Northwest Truss Diagonal L2-U3 is bowed outward (north) up to 5", looking east. Condition is typical at numerous diagonals.

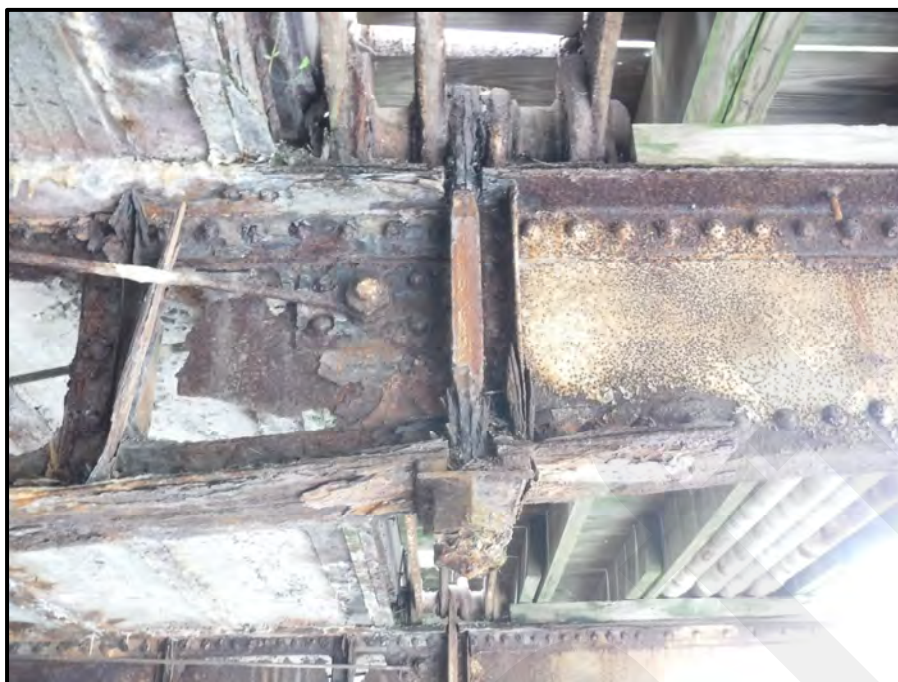
**Photo 22:** The hanger rod at the south end of Floorbeam 7 exhibits severe laminar corrosion with 1/2" remaining thickness metal (RTM) locally where it passes through the floorbeam's upper and lower flanges (original thickness is 1-1/4"), looking east. Note the rod exhibits 50% min. (est.) section losses around the pin. Also note the severely holed-thru floorbeam web and the severe laminar corrosion on the flanges. All conditions are typical at nearly every location.

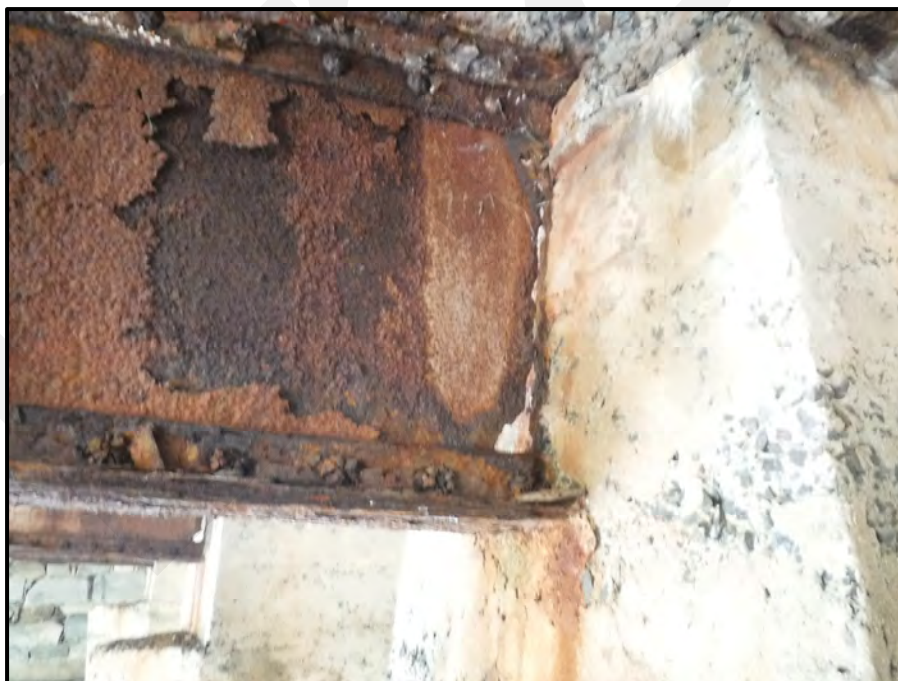
**Photo 23:** The Floorbeam 8 web is holed-thru for its full height x 2"W at the interface with the south face of Pier 8, looking west.

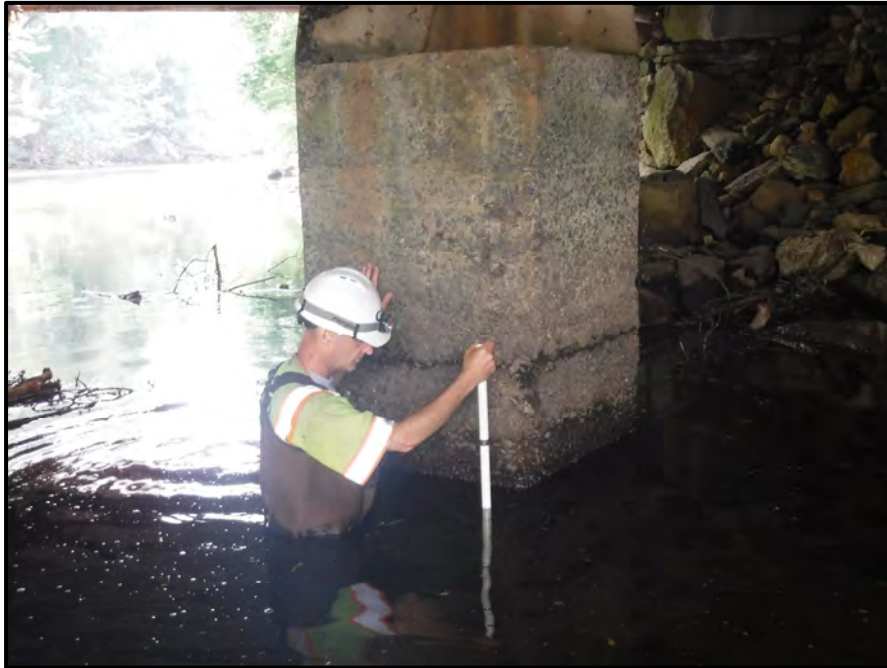
**Photo 24:** Inspector is standing on top of the exposed footing (up to 9" vertically) at the upstream (north) nose of Pier 1, looking south. No undermining was detected, and similar conditions exist at Piers 2, 6, 8, and 9. Note the concrete abrasion up to 6" deep throughout the base of the pier, typical throughout all piers.

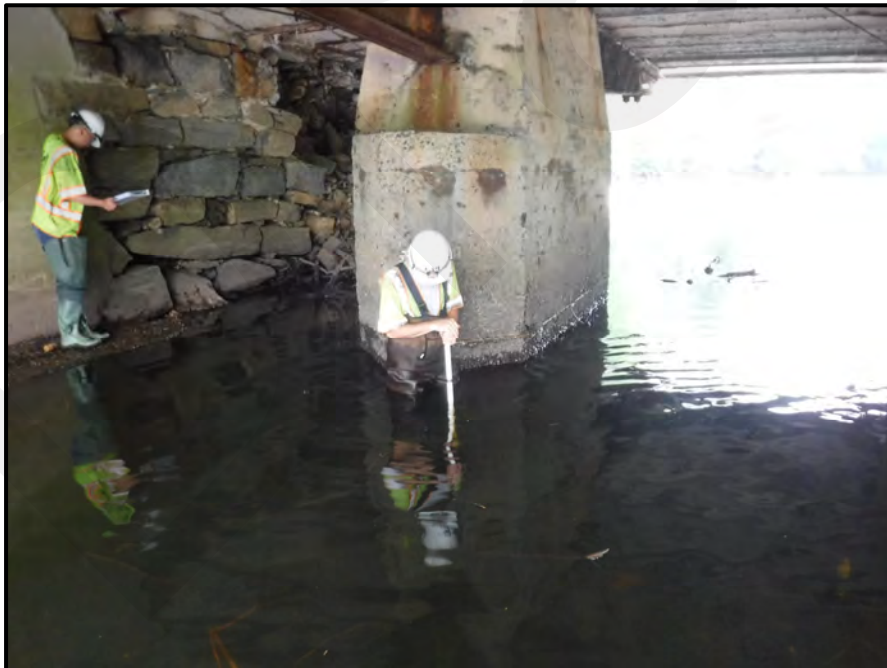
**Photo 25:** The footing at the upstream (north) nose of Pier 4 is exposed up to 1'-7" vertically, looking south (no undermining was detected). Note the random cracks and light rust staining scattered throughout the pier, typical throughout all piers. Additionally, note the inspector standing on top of the exposed footing / scour protection wall along the concrete reconstructed north end of Pier 5 (original lone / center pier) (left).

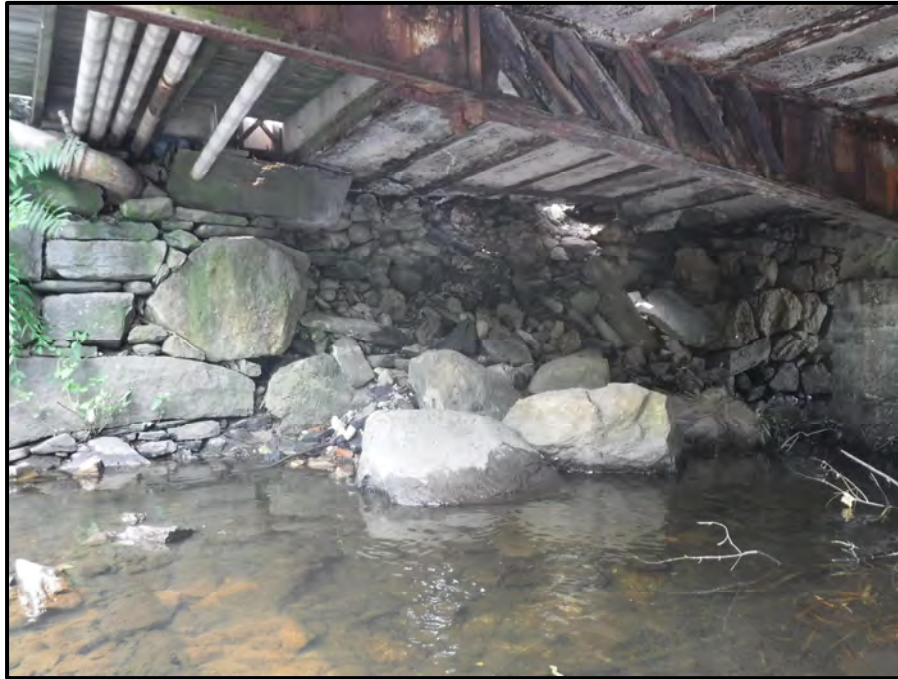
**Photo 26:** General view of the previously failed portion of the dry stacked stone West Abutment, looking west. The extent of the loosened blocks bookending the collapse appears to have worsened since the 2018 inspection. Also note the ends of Stringers 14 thru 25 (north trolley stringer to south fascia) are unsupported as a result and appear to be displaced downward several inches.

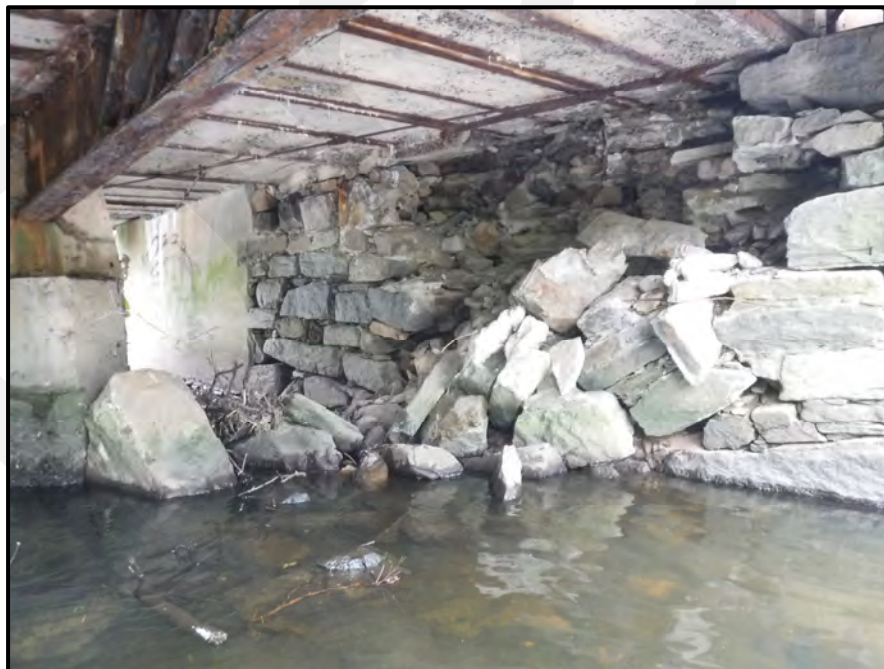
**Photo 27:** General view of the previously failed portion of the stone masonry Pier 5 (original / lone center pier), looking northeast. While the length and height of the collapse are generally the same, the depth extends up to 4'-6" max., leaving only about 1'-6" remaining thickness and resulting in limited support for the east end of the south truss and Stringers 16 thru 25. Note the failed masonry blocks are laying in the river and block the Span 5 channel for a 3'± height.

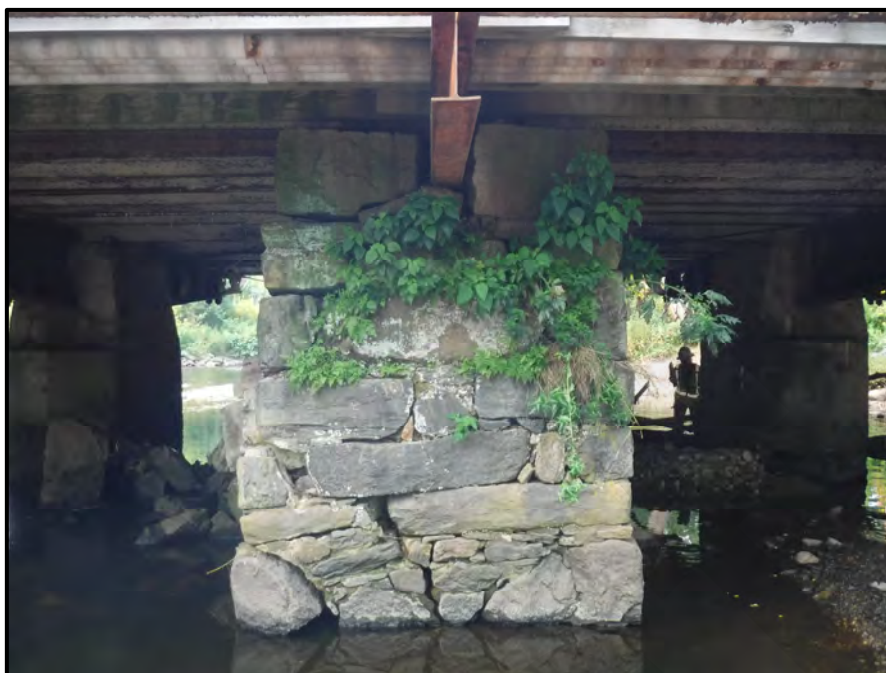
**Photo 28:** General view of the south nose of Pier 5 which exhibits loosened and displaced blocks up to 9" outward on the west face (left), looking north.

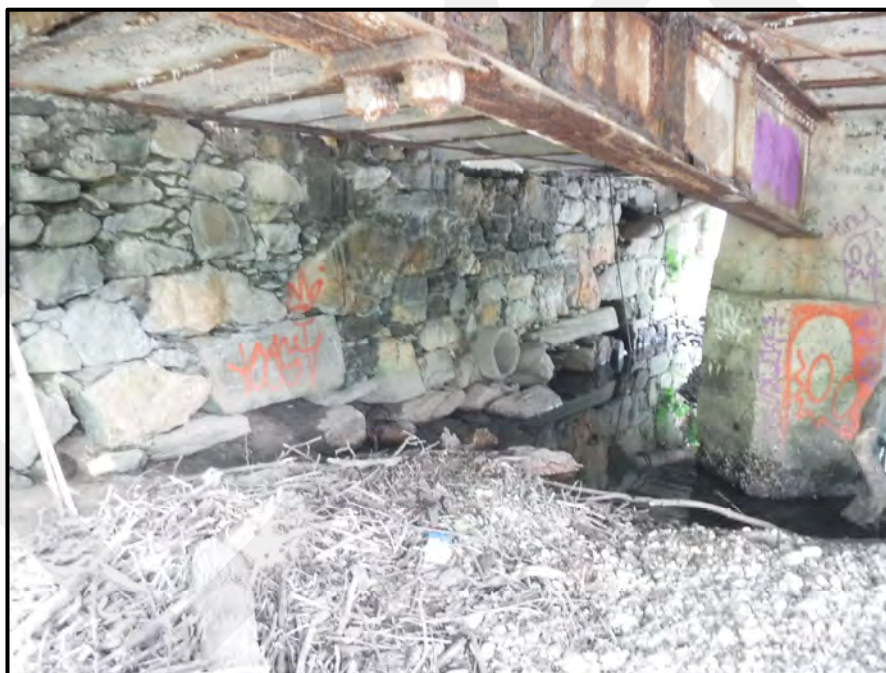
**Photo 29:** General view of dry-stacked East Abutment which exhibits deep voids (1.5 SF x 5'+D) throughout and loose stone surrounding the “punch-through” for the utility pipe, looking southeast. Note the broken superstructure cross-bracing in Span 10.

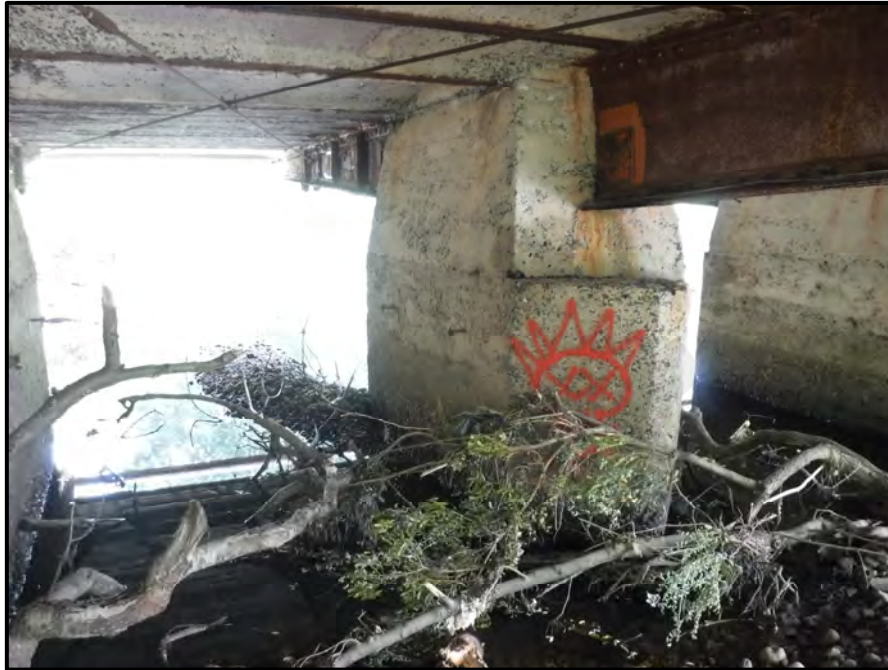
**Photo 30:** Drift and debris accumulation at the upstream (north) nose of Pier 8, looking south. Condition is typical to varying degrees at all nine (9) piers.

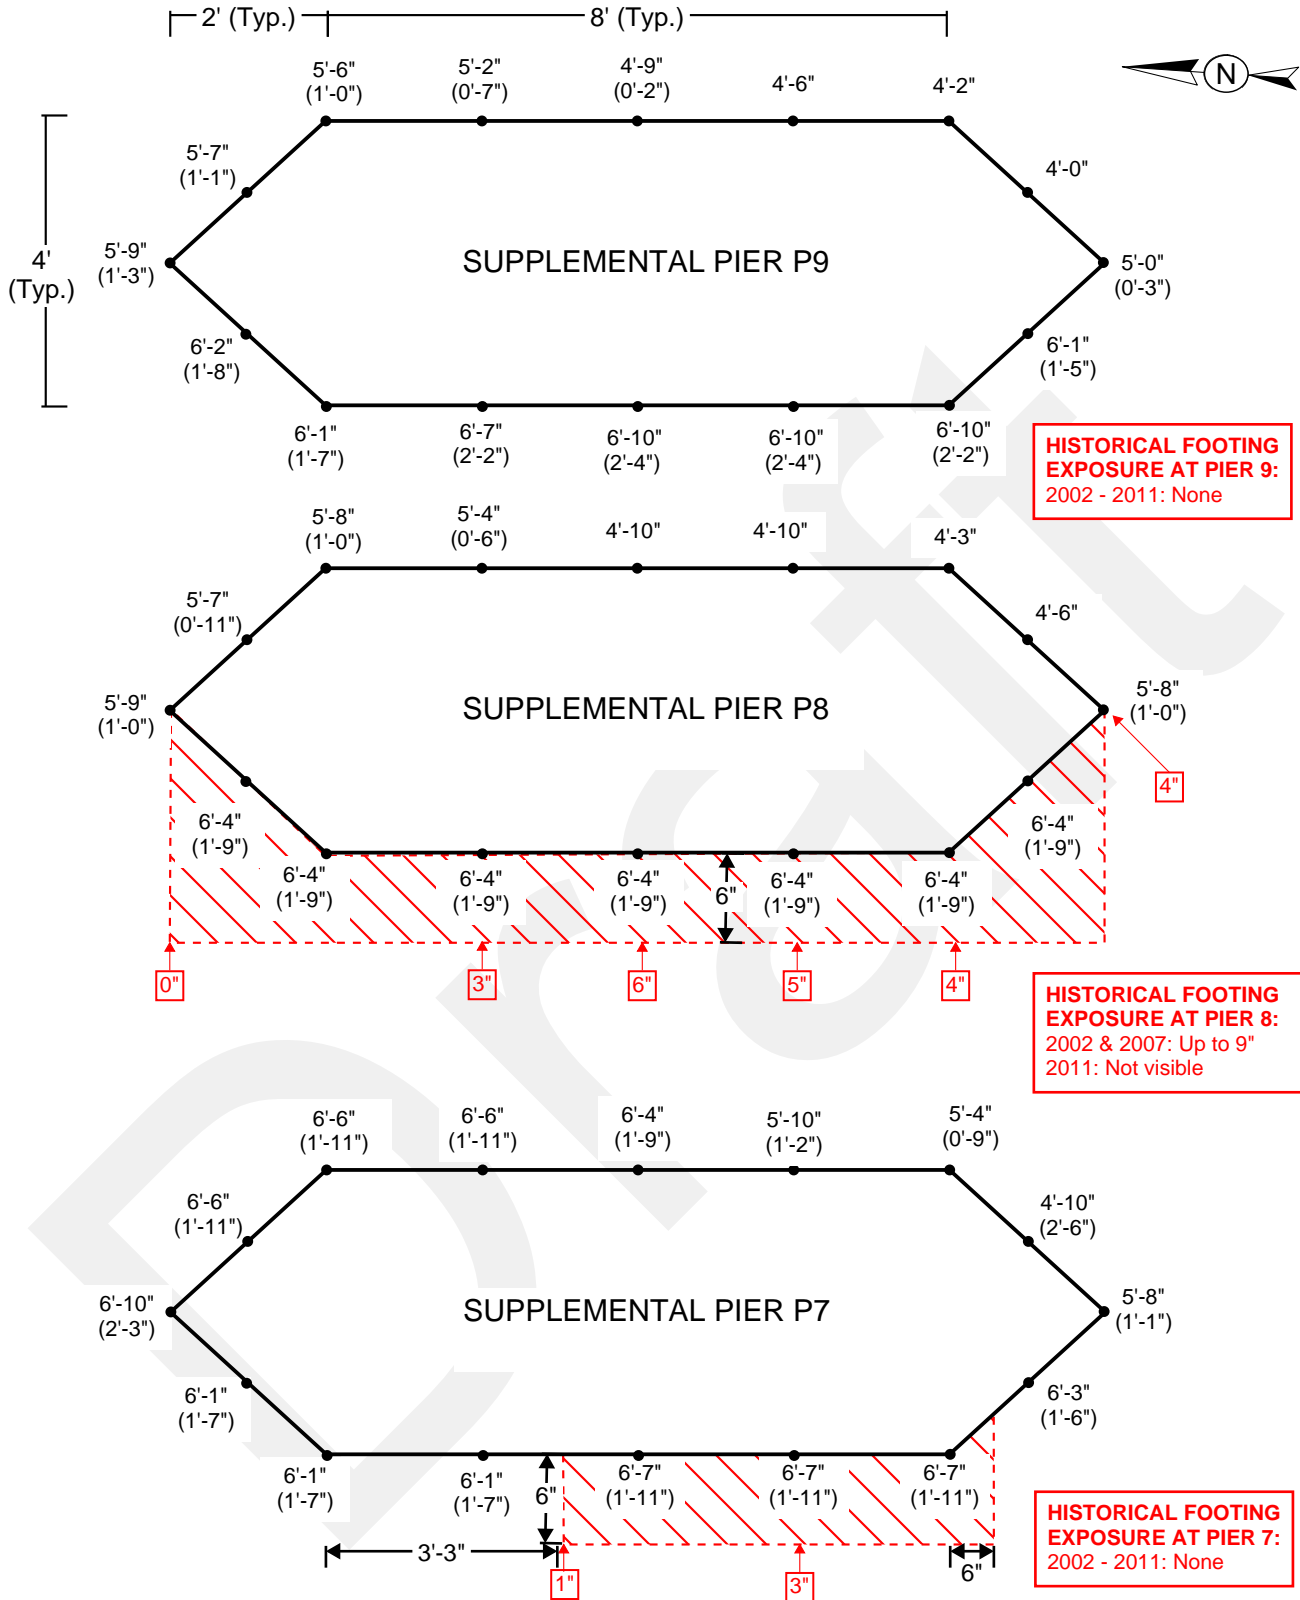
**APPENDIX A**  
**SCOUR SKETCHES**

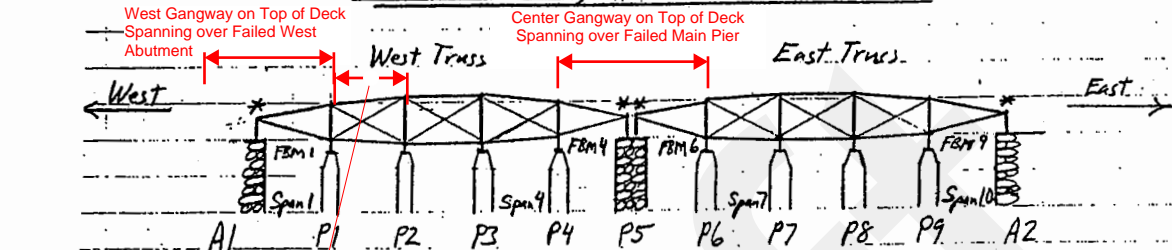
Underdeck Spall between Floorbeams 1 & 2
