Stamford Harbor Master's Report 9/12/2017

Supplemental Report to Harbor Safety Committee

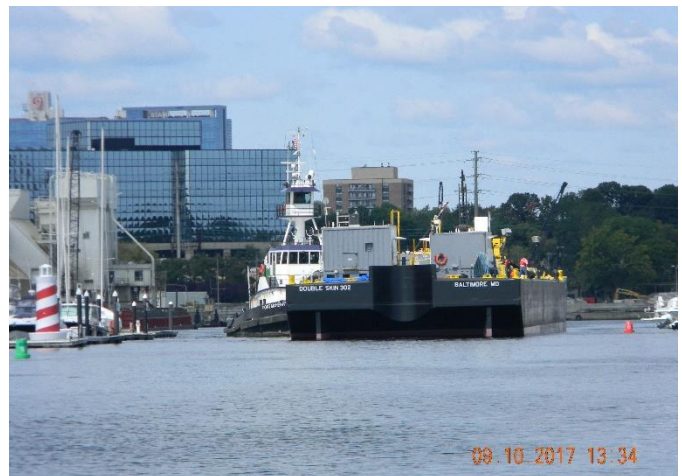
Figure 1

- At the request of the tug's Master, I assisted with the outbound passage of the tug and oil barge (*see figure 1*). Several incidents occurred during the passage worthy of note;

- The previously mentioned Carefree Boats Club vessel was out of control trying to dock

causing the tug/barge to back-down to reduce speed. The club dock staff were unaware of the approaching tug/barge when I spoke to them.
