# STAMFORD ROAD SAFETY AUDIT

ROUTE 137 (WASHINGTON BOULEVARD)

NOVEMBER 2023

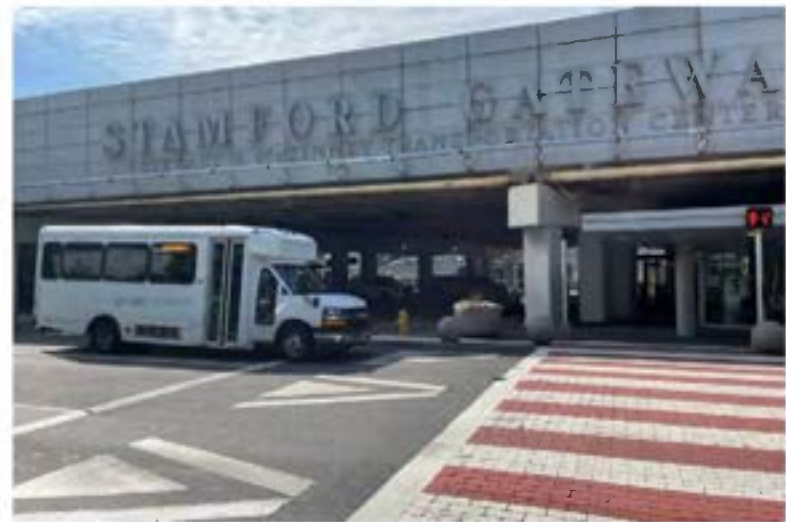
*Exhibit 30: Crosswalk with an automated pedestrian detection system at Stamford Transportation Center entrance on North State Street*

- This intersection is near to the mid-block crosswalk of North State Street between the Transportation Center and a private pathway to points further north along the property of 677 Washington Boulevard. This is a very busy and most common walking route for people going to or from the Transportation Center and Downtown Stamford. This crossing features a raised crosswalk and an automated pedestrian detection system. RSA participants from the city noted that these features have greatly improved pedestrian safety at this location. Exhibit 30 displays a photo of this location.

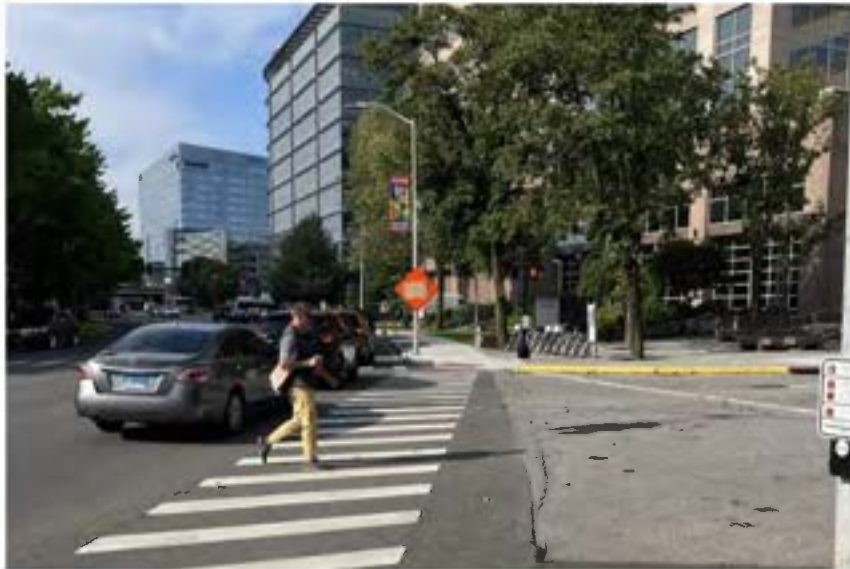
*Exhibit 32: Washington Boulevard looking south through the intersection of Division Street.*

- RSA participants suggested removing the option to turn left from Washington Boulevard to Division Street. Exhibit 32 displays the view south at the Division Street intersection.
- Traffic often backs up past Richmond Hill Avenue past this intersection.
- Traffic signal equipment at this intersection is older than other intersections. The intersection does not feature any dynamic “No Turn on Red” signs as found in other intersections.

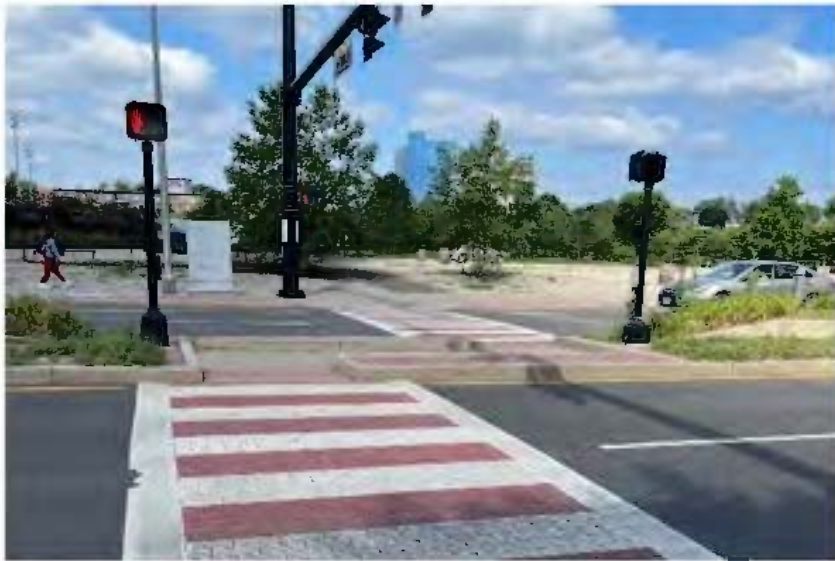
*Exhibit 37: The Pedestrian Hybrid Beacon (or “HAWK”) in front of Mill River Park*

- RSA participants noted that while the staggered crosswalk protects pedestrians, it is not very accessible for all pedestrians. Residents with physical impediments and wheelchairs have trouble maneuvering the crosswalk. Exhibit 37 displays an example of this crosswalk.
- The landscaped median needs to be trimmed in this area to allow for better pedestrian visibility.
- RSA participants also suggested that the connection between Mill River Park and the rest of the parks system should be considered.
- Some driveways are not constructed at sidewalk grade. These should be located at sidewalk grade in the future to preserve the pedestrian space.

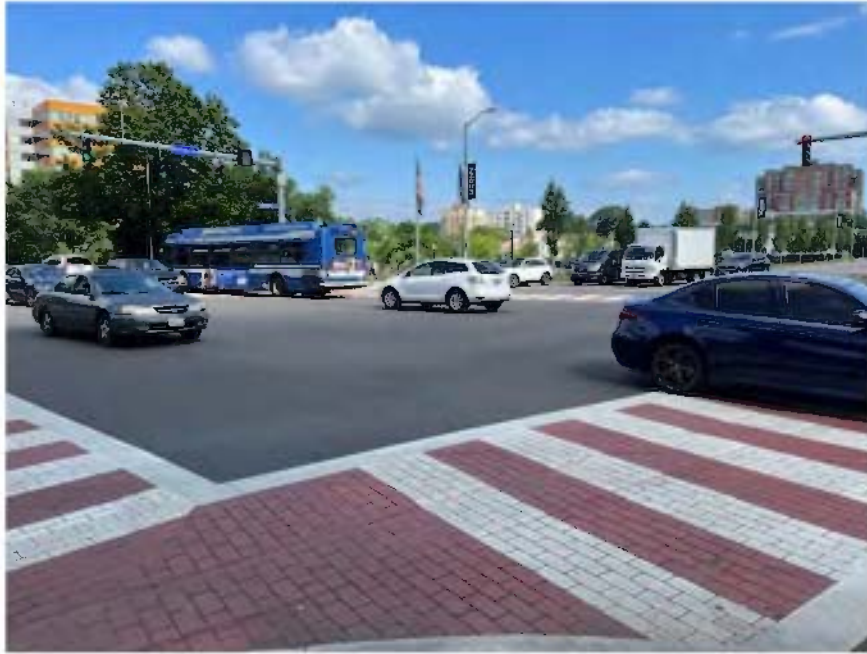
Exhibit 38: Broad Street and Washington Boulevard intersection, view north

- Right turns are problematic at this intersection as well. All approaches, to this intersection except the eastbound approach, have a dedicated right-turn lane. Vehicles frequently fail to yield to pedestrians in this configuration.

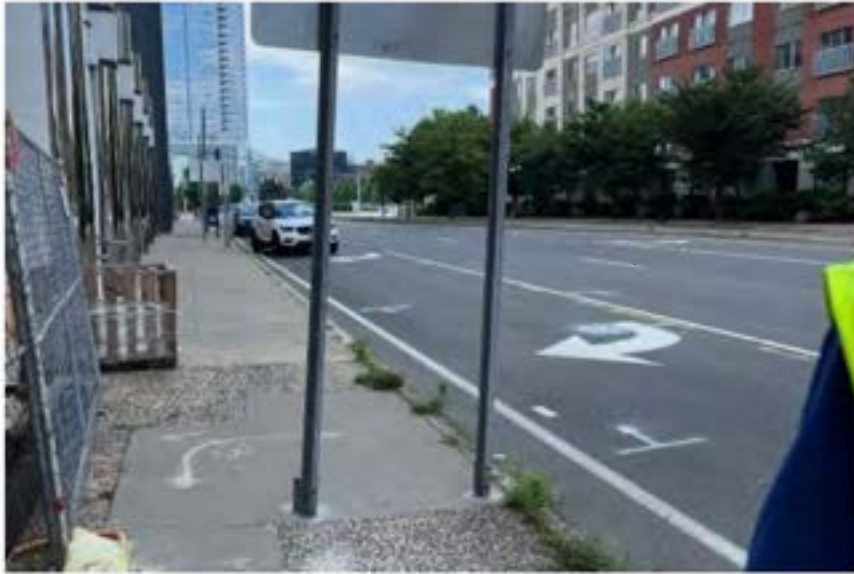
Exhibit 40: Sidewalk near the North Street intersection

- RSA participants noted that there needs to be consideration of left turn signals for North Street.
- Some areas along the sidewalk network need to be updated, including those shown in Exhibit 40.

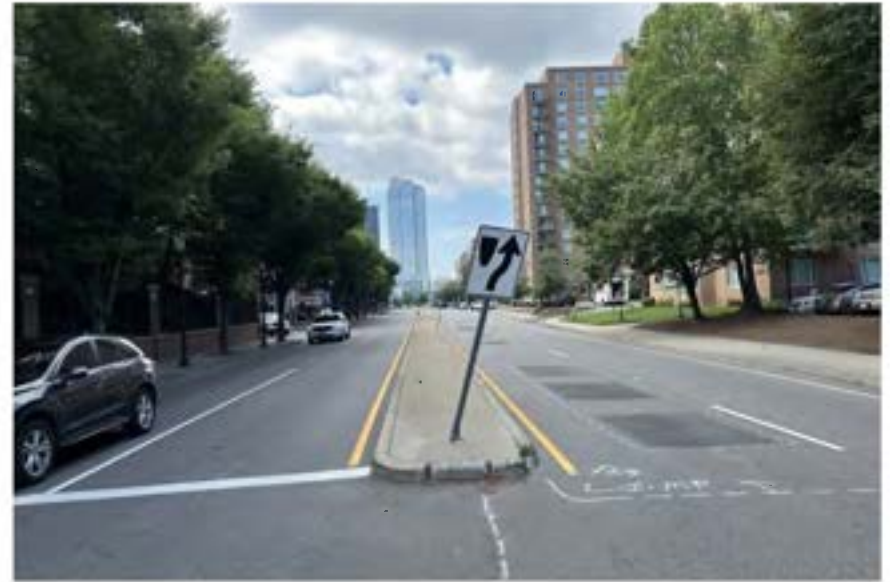
Exhibit 41: Washington Boulevard, view south, from the intersection of Hoyt Street

- RSA participants discussed the median island in this section. While this is visually unappealing, participants noted that this does help with eliminating some left-turn movements from the apartment drop off areas. Exhibit 41 displays this median.
- This area is among the narrowest sections of Washington Boulevard in our study area.
- Sidewalks in this area are narrow and adjacent to traffic.
