# STAMFORD ROAD SAFETY AUDIT

ROUTE 137 (WASHINGTON BOULEVARD)

NOVEMBER 2023

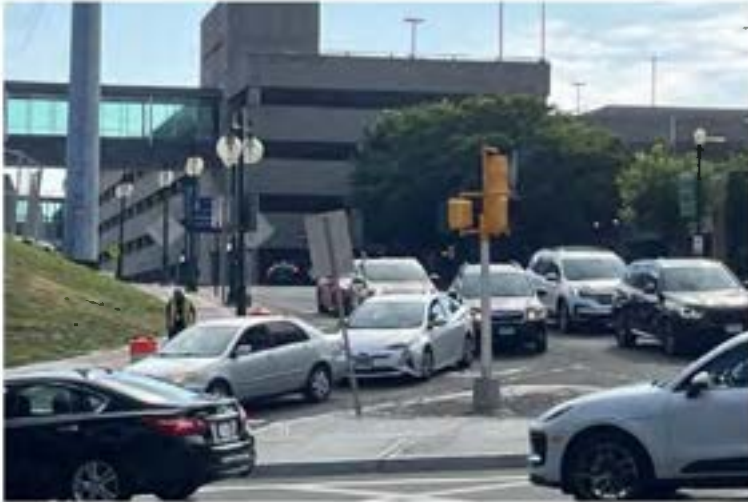
- This segment is highly trafficked by both pedestrians and vehicles due to the Metro North Stamford station on Station Place.
- Station Place is also a state road serving the Stamford Transportation Center. RSA participants noted that the right-turn from Station Place

*Exhibit 26: Station Place, view east, from Washington Boulevard. Stamford Transportation Center Parking garage in the background*

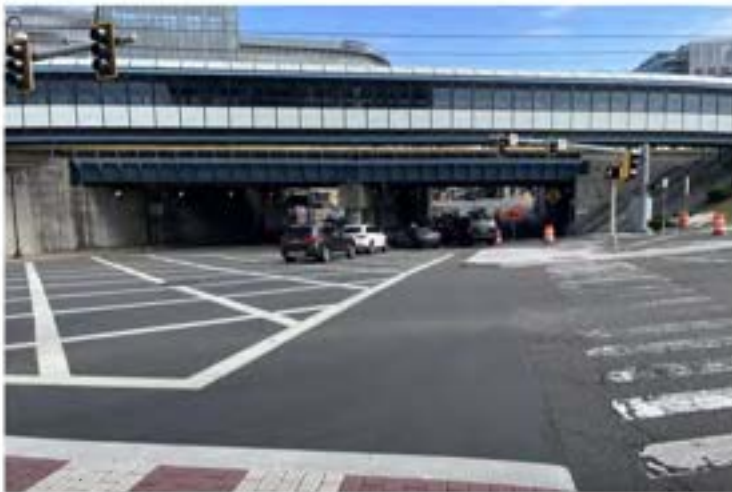
- Lighting conditions on the Metro-North tracks were poor. Sidewalks are relatively narrow. Exhibit 27 shows this area under the tracks.
- RSA participants noted that the bridge walls and columns could be an opportunity for art and/or visual wraps (e.g., around bridge columns).

*Exhibit 27: Station Place and Washington Boulevard intersection, bridge underpass in distance*

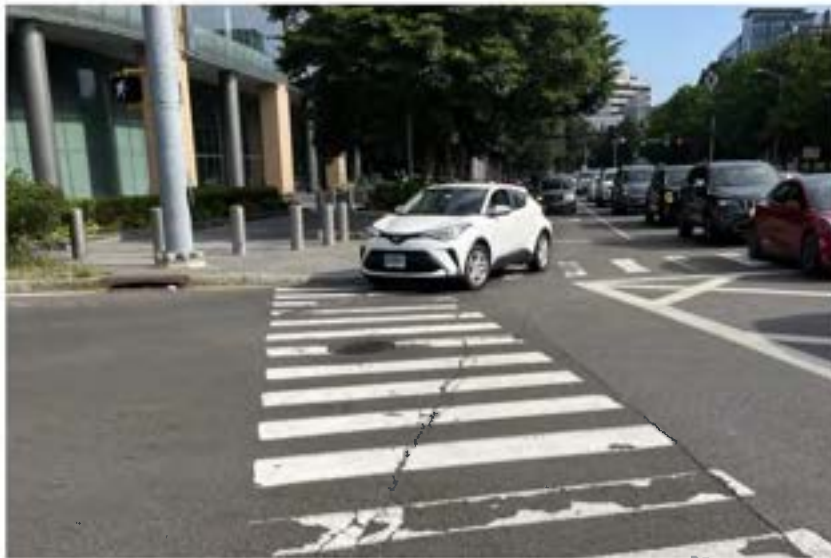
- This intersection includes the I-95 southbound on-ramp and includes heavy turning volumes from both the southbound and northbound directions to I-95. The southbound right-turn to I-95 is a dedicated right-turn lane and it is a difficult leg to cross as a pedestrian. Exhibit 28 displays this location.

*Exhibit 28: Looking northbound across the crosswalk across the I-95 on-ramp. Note the right-turn lane in the southbound direction*

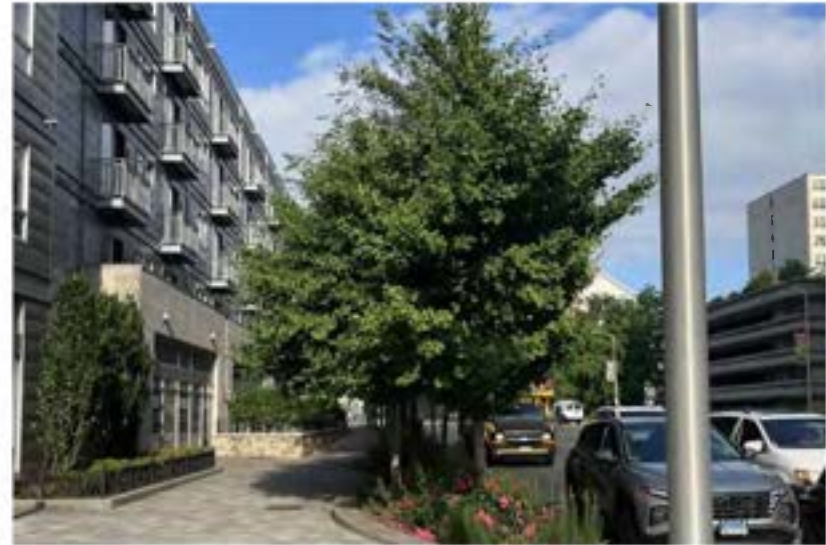
*Exhibit 33: Separation and landscaping near 75 Tresser Boulevard*

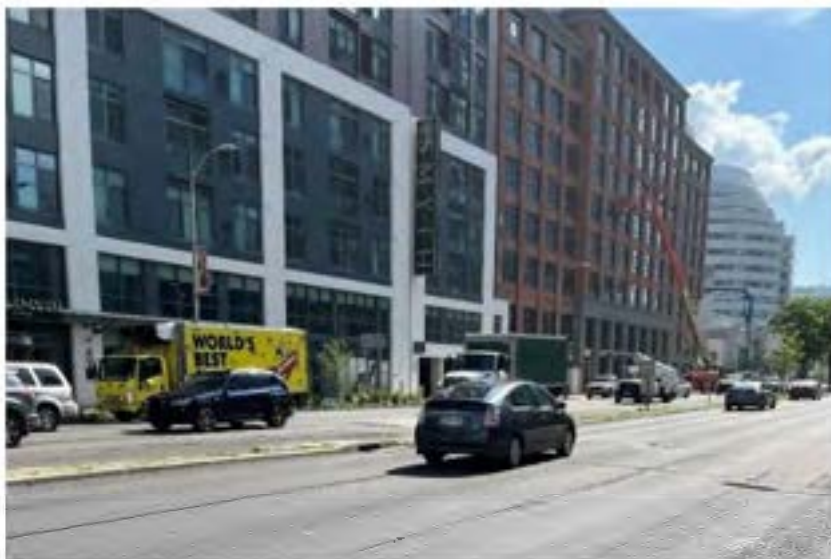
- This intersection is a hotspot on the crash heatmap.
- RSA participants noted that lighting could be improved at this intersection. RSA participants noted no visible street lighting to the north and all installed lighting was pedestrian scale only. Participants discussed light pole options that include both luminaires for both the street and sidewalk side of the pole.
- Island vegetation blocks sightlines for both drivers and pedestrians due to the height of the vegetation. It should either be lower or higher (e.g., tree canopy).
- RSA participants also noted the inconsistency of landscaped medians with none existing from Tresser Boulevard to Station Place. Exhibit 34 displays a picture of a median in the corridor.

*Exhibit 34: Median on Route 1 to the east of Washington Boulevard*

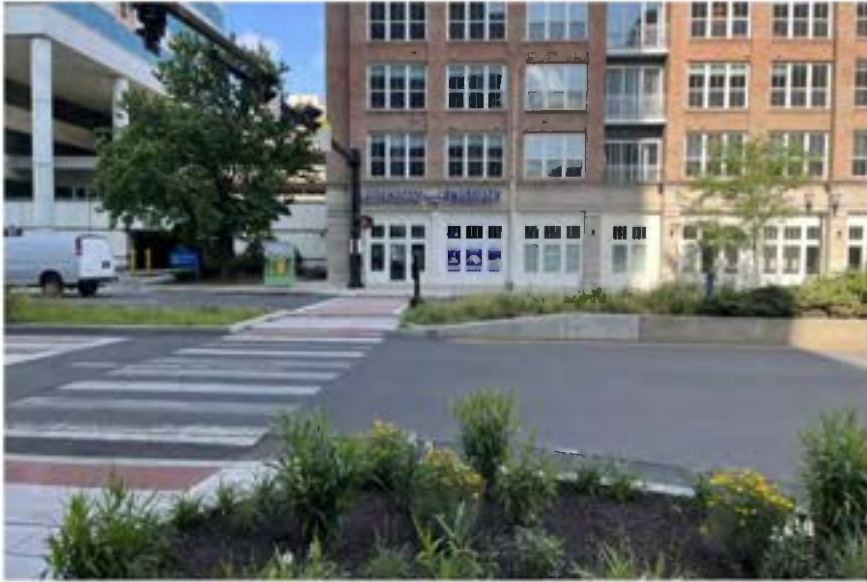
- The Pedestrian Hybrid Beacon (also known as “HAWK”) was recently reconfigured to remove the “zig-zag” which was confusing to pedestrians and caused accessibility concerns. Feedback has been positive. Exhibit 35 shows a picture of this location.

Exhibit 35: Pedestrian Hybrid Beacon (or "HAWK") south of Bell Street

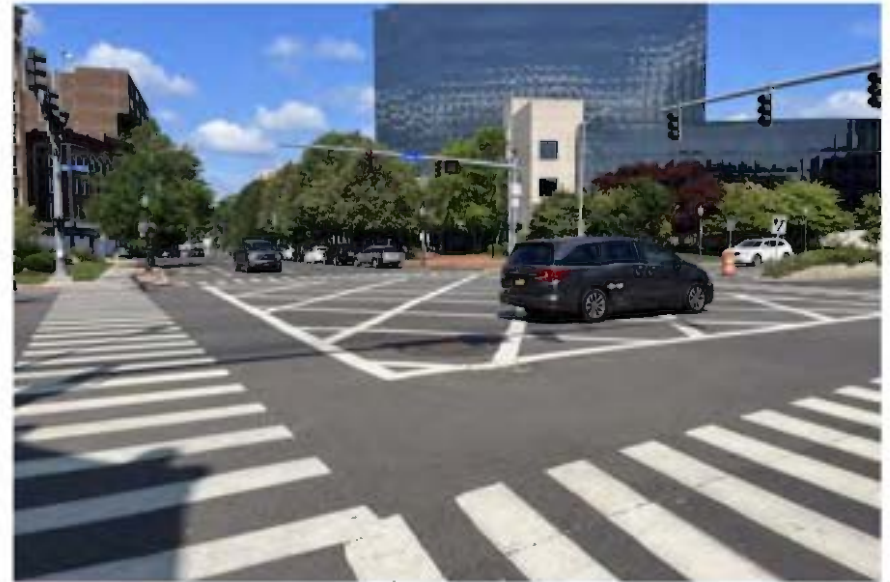
- The Main Street intersection is a busy location that is near to many destinations such as restaurants, government centers, Mill River Park, and more. Exhibit 36 shows this location.
- Recent pedestrian fatalities have called attention to the importance of protecting pedestrians along this section of Washington Boulevard.
- The City of Stamford has recently received approval to install temporary bumpouts at Main Street and Washington Boulevard.
- Long-term the City would like to consider a raised intersection, removal of all right-turn lanes, and a hardened centerline where feasible.

Exhibit 36: Intersection of Washington Boulevard and Main Street looking west

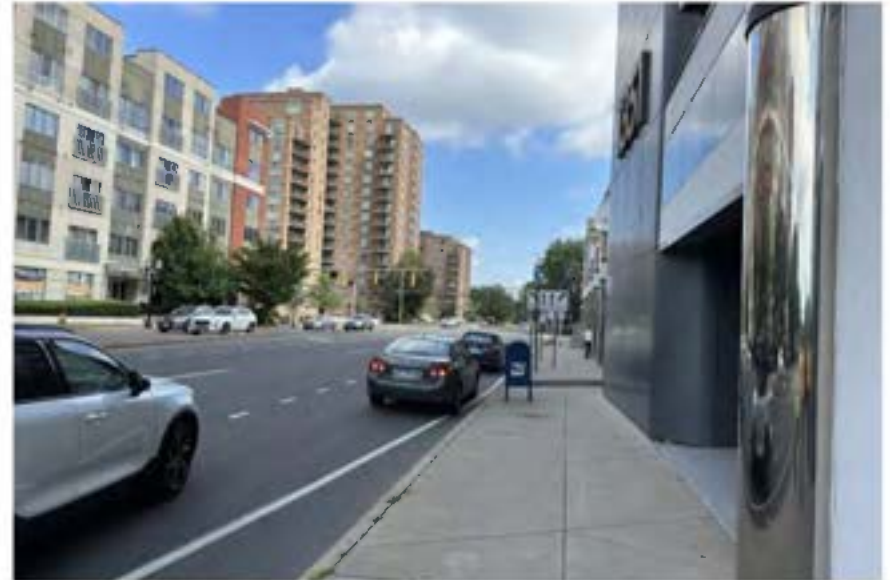
- The southbound approach to the UConn Parking Lot traffic signal is confusing. It is unclear if the short curbside lane is a bus pull-out or a through lane or a right-turn lane.

Exhibit 39: Washington Boulevard looking north towards North Street

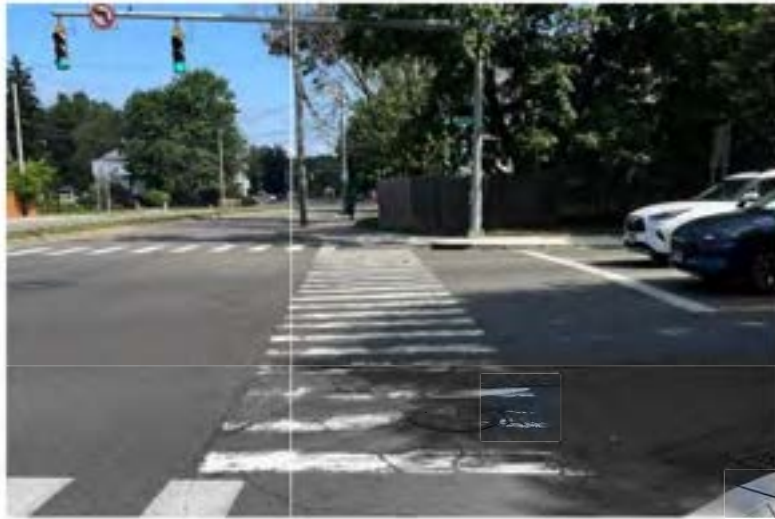
- Hoyt Street is used as an east / west connector.
- Exhibit 42 displays vehicles coming from the east between Summer Street and Washington Boulevard.
- Consider removing the right turn lane at Hoyt Street for parking.
- Currently Linden Place is entry only off Washington Boulevard southbound. There is a median island extension on the north side of the intersection to prevent through movements from Hoyt Street. There are some landscaping businesses down Linden Place that need to maintain access.

*Exhibit 42: Hoyt Street Intersection with the no left turn sign onto Linden Place*
