# CITY OF STAMFORD

## Glenbrook Community Center

#### FACILITY CONDITIONS ASSESSMENT

March 6, 2020

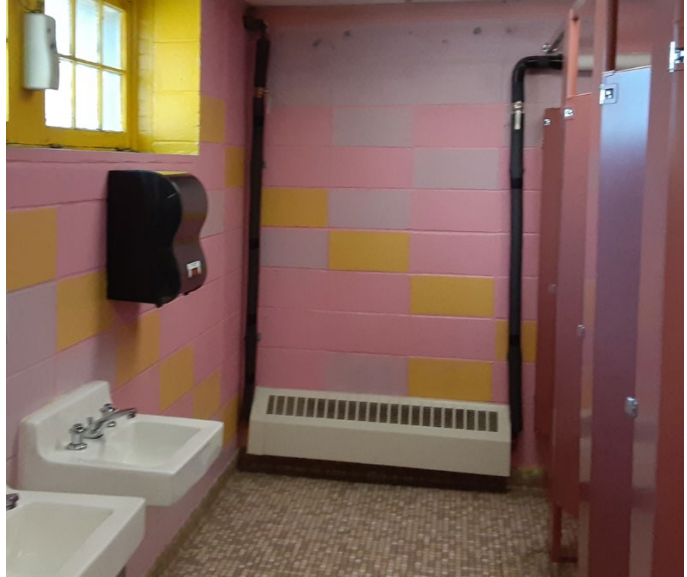
Exterior Bathroom Heating

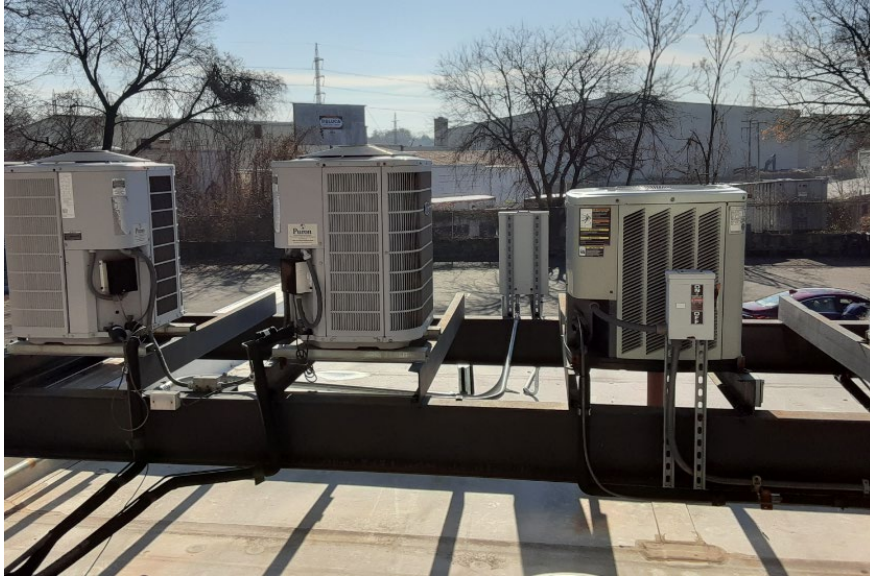
**Exterior Condensing Units Located above Restrooms**

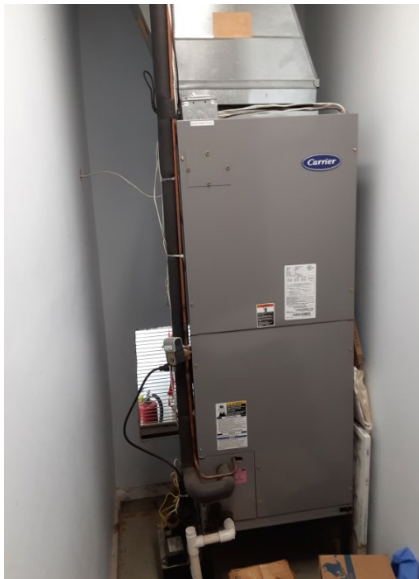
**Typical 2<sup>nd</sup> Floor Closet Mounted Air Handling Unit**

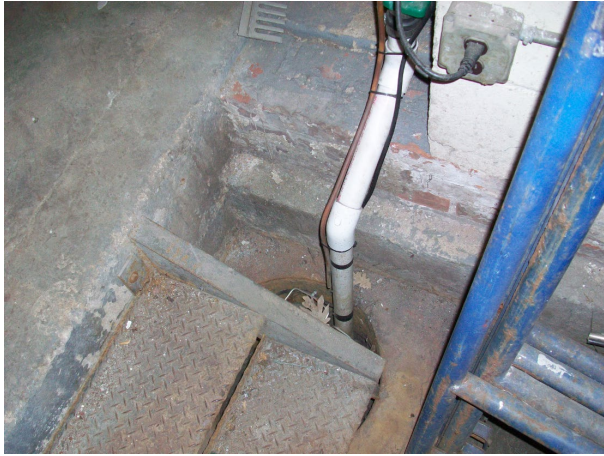
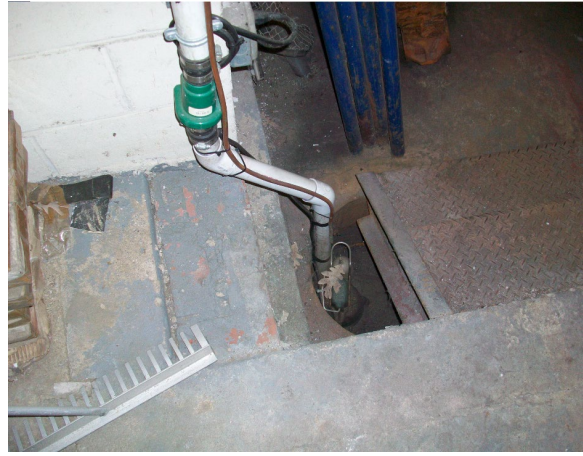
The pump is located in the boiler room adjacent to the water heater in a shallow pit. Discharge piping is 2" PVC and is provided with a check valve. This piping was recently reconfigured to avoid obstructing

the exit stair. Piping is connected to the main sewer line via gravity, there is no cover on the sump pit and it is powered via plug in power supply.

The current sump pump is still operational yet nearing its useful life expectancy. Provide a new stand-by pump for quick swap out in the event of premature failure. Additionally, provide a high water alarm with remote indicator and new basin cover.

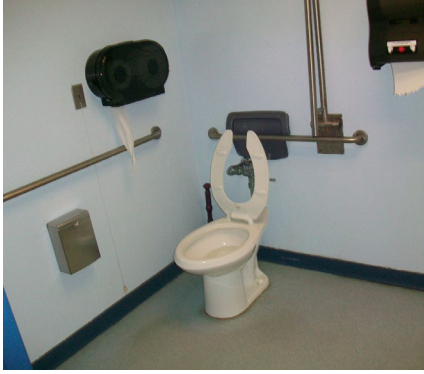
The toilet rooms are in need of upgrades both for accessibility and also due to old and worn finishes. The handicap toilet room on the second floor is missing grab bars which have been added by recent code updates. The two other toilet rooms on the second floor are in poor condition and need new finishes, toilet partitions and plumbing fixtures. The rear group toilet rooms are not accessible and will require a redesign to accommodate handicap compliant toilet stalls and wider entrance doors.

Second floor ADA unisex toilet room

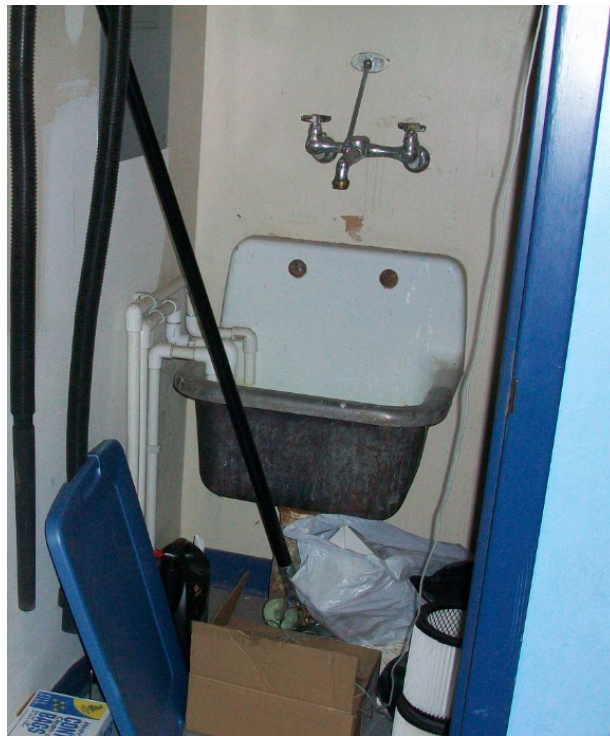
The building is provided with a sanitary and vent system piped throughout the facility to support all plumbing fixtures. Drainage issues have been noted towards far end of building, specifically at a mop sink (which is the farthest run from the sanitary exit point). Multiple interior and exterior cleanouts were observed and are in accordance with code. The building drainage connects to the municipal sanitary sewer via gravity, and all venting systems terminate thru the roof to atmosphere.

Mop sink

It is recommended to snake all floor drain, mop sinks, and below slab sanitary and waste piping clean to ensure the system is not obstructed and that it is free of debris to allow proper drainage. Perform camera scope test on building's main drain to document condition of the piping and verify routing and invert elevations (if future connections are anticipated). Cut in new cleanouts where required by code to facilitate cleaning, sawcut, trench, patch and repair floor accordingly. Repair damaged piping as necessary.

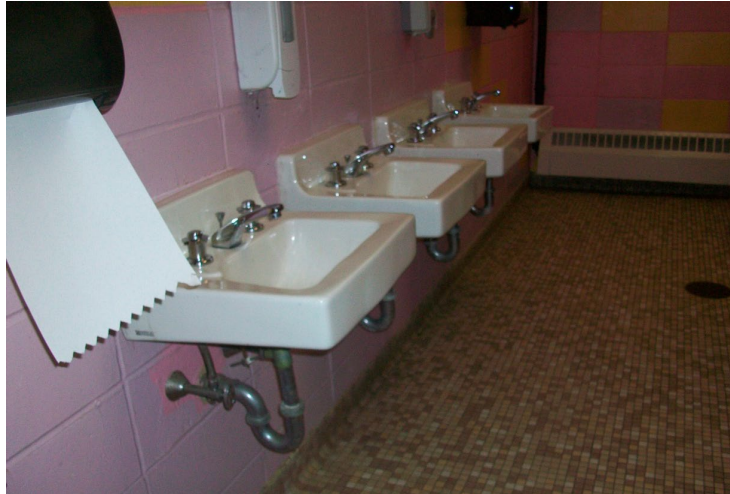
Lavatories in the Restroom annex

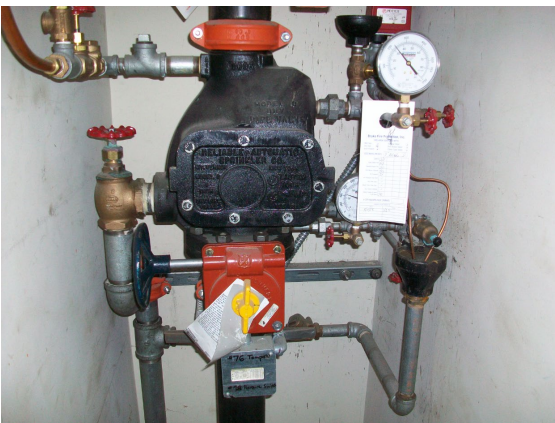
Dry pipe valve

Based on the piping material used and the characteristic of testing a dry type sprinkler system it is likely that the piping distribution system has areas of internal corrosion from the annual wetting / drying cycles due to testing. The result is that water flow to the sprinkler heads can become obstructed in the smaller piping as oxidized material is removed / scoured off from the internal pipe surface during an event, thus compromising the life safety systems performance and ability to protect the occupants and property.

Sample the existing system in accordance with NFPA 25 (by a recognized testing laboratory acceptable to the authority having jurisdiction for field service testing) to determine the extent of corrosion, corresponding performance capabilities, and immediate life expectancy of the system.

Provide a nitrogen generator which charges the dry system with inert gas in lieu of standard compressed air, which provides unfiltered moist air. This is to eliminate internal pipe corrosion typically found in a dry system, which in turn helps maintain operation and increase longevity of the dry system.

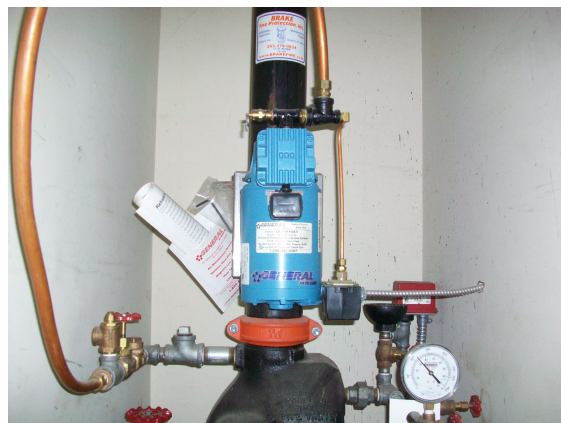
Maintenance air compressor

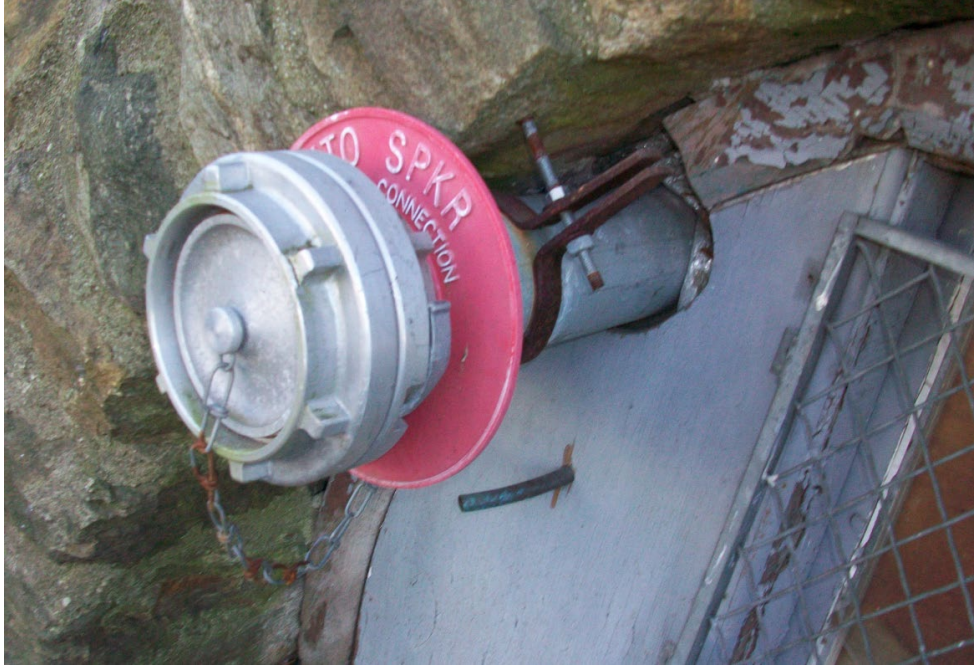
Stortz fire department connection

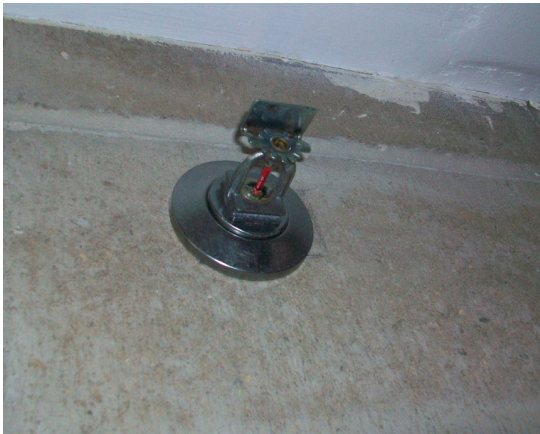
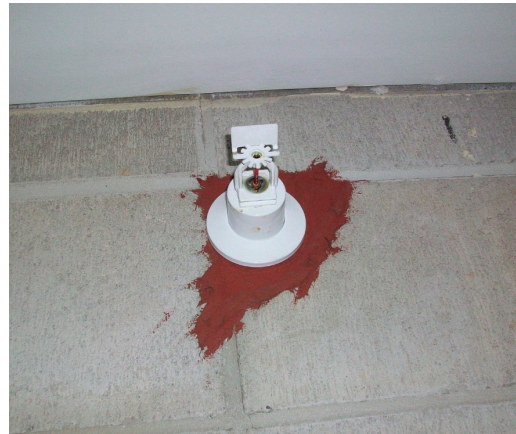
Additionally, sidewall sprinkler heads are utilized in the building. Note that piping off the wet system serving a sidewall head located in the unheated restroom annex's storage room had burst due to freezing temperatures. The sidewall head has been replaced with an appropriate dry barrel sidewall type, but the remaining head is prone to freezing / failure as well.

Replace the wet sidewall sprinkler with a dry barrel sprinkler head in the unheated restroom annex's storage room.

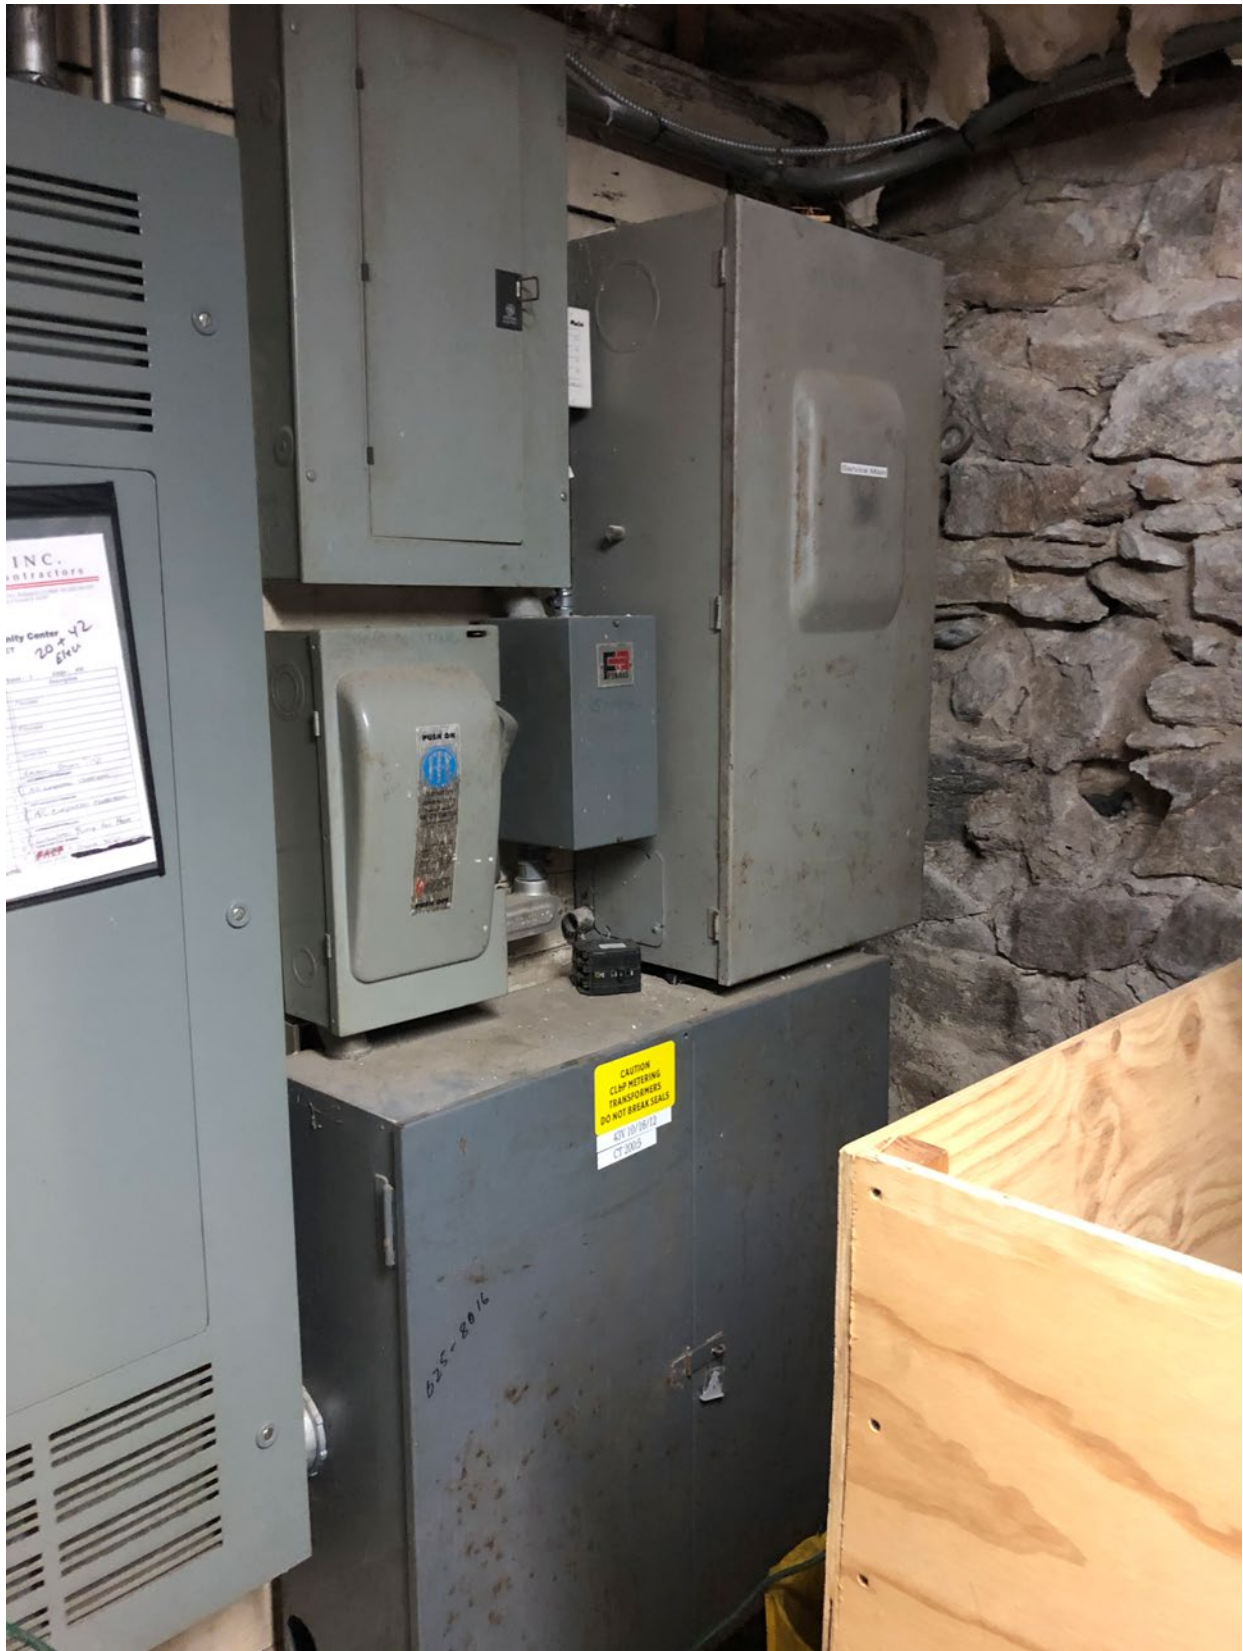
Main Electric Service Entrance in Electrical/Mechanical Room
